Mariners' Alerting and Reporting Scheme

MARS Report No 348 October 2021

MARS 202148

Engine crewmember dies during piston replacement

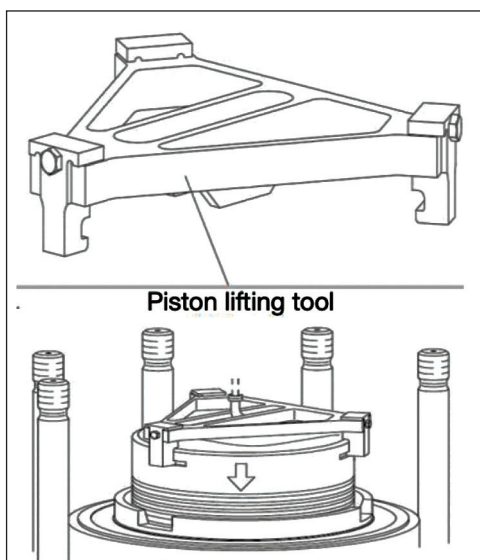
The task had been started in the morning, and in the late afternoon, the crew commenced the re-installation process. This last but critical phase of the overhaul would take about an hour, and included using the piston lifting tool. The lifting tool has two stationary claws and one adjustable claw. The claws sit in the piston lifting grooves on the top of the piston.

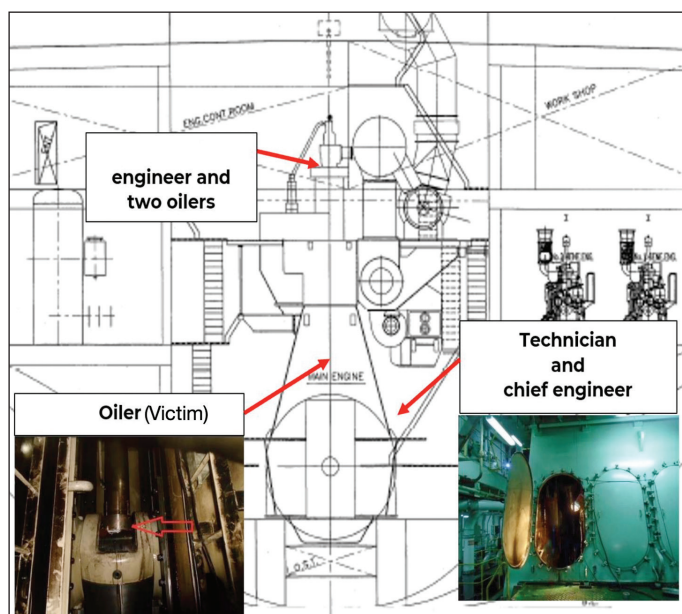
Soon after, the chief engineer instructed an engineer to turn the engine using the turning gear. The other engineer dropped the piston lifting tool. A loud noise was heard; the piston had dropped inside the crankcase. The oiler who had remained inside the crankcase was found unresponsive in the sump tank of the main engine. Emergency procedures were taken but the oiler was declared deceased before his arrival at the hospital.

- The existing risk assessment for this job indicated that crew should take the engine manufacturer's instruction manual into account while planning the operation. However, in this case the manual was not discussed beforehand and several steps mentioned by the manufacturer were not followed by the crew members during the operation.
- The chief engineer was the supervisor of the operation. However, he did not have a portable VHF radio with him while the task was being carried out. Furthermore, the communication between the two other engineers was in a language not understood by the chief engineer.

- Before carrying out any high-risk operation, such as overhauling and maintenance of the main engine, the manufacturer's instructions must be discussed and incorporated in the planning of the operation.
- A thorough review of the risk assessments for any high-risk operation must be carried out to identify the hazards and risks associated with every stage of the operation. Appropriate safeguards to eliminate those risks should be put in place.
- Effective communication should be established while carrying out any operation onboard. The supervisor of the operation and all involved crew members should be equipped with the appropriate communication devices and communicate in the vessel's working language throughout the operation.

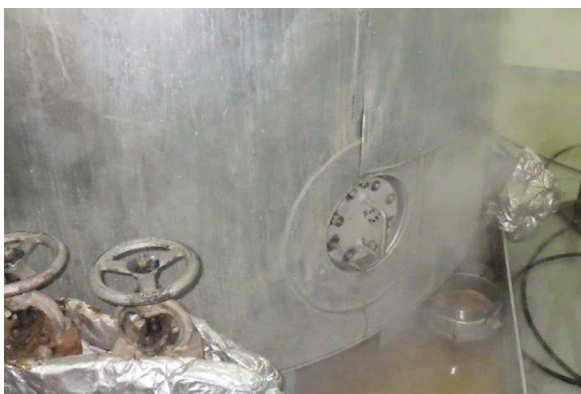
Assuming it was safe, he then decided to remove the upper section of the maintenance hole, followed by the lower part. Suddenly, a mix of water and steam came out of the orifice and hit his body. The victim was admitted to the shore hospital with first and second degree burns on his legs, arms, belly and feet.

The company investigation revealed, among other things, that the boiler indicator habitually did not go lower than a certain level, a quirk that could give an uninitiated crewmember the impression it was empty when it was not. This vital information is not mentioned in the boiler manual and was only known by the more experienced engineers on board, not the victim. Additionally, the company found that the job scope had not been properly communicated to the victim and no permit to work was issued to carry out the job on the boiler that day. Finally, no Lock-out/Tag-out (LOTO) was applied.

- The supervision of junior employees remains a vital element of safety, especially for non-routine tasks and particularly when it is the first time the person is attempting that task.
- Remember – the large skill and experience gap between senior and junior officers may lead to misunderstandings and assumptions.

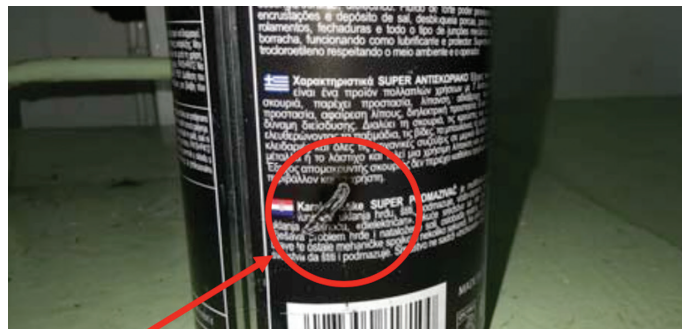
welding process came into contact with a small can of spray lubricant. The spark punctured the pressurised can, immediately generating a flame burst that injured the crewmember.

Hole where welding spark initiated a flame burst

- Welding is a dangerous business and the job site should be clear of all combustibles, debris and other non-essential items.
- Complacency is often a contributing factor in accidents. We must encourage an approach where each task is approached with caution – as if it were the first time it was being undertaken.
- Supervision and safety leadership are critical. Where improper routines or unsafe practices are noted, intervene and arrange for appropriate instruction and/or training.

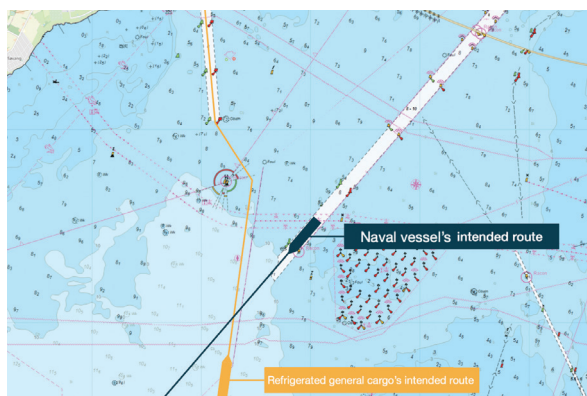
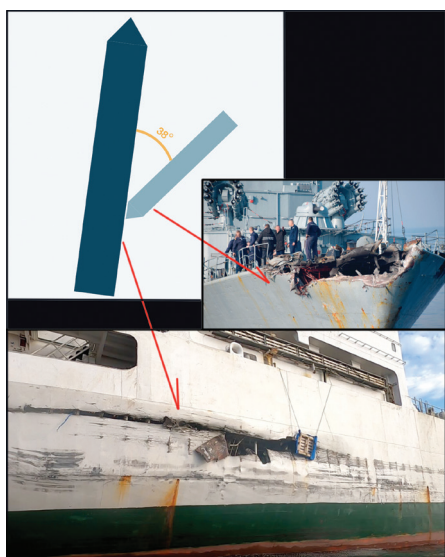
Shortly afterward, the other vessel appeared abeam and slammed into their starboard side. The Master and OOW saw that this was another naval vessel similar to the one that had passed ahead a few minutes earlier.

Shortly after the collision, the cargo vessel dropped anchor to better assess the situation. The damage incurred was above the waterline and there was no risk of pollution. In the meantime, the naval vessel was adrift and was assisted by the other naval vessel which had returned to the area.

The official investigation found, among other things, that several coinciding factors contributed to the bridge team not recognising the risk of collision until the naval vessel was at close quarters. These included the layout of the bridge, the configuration of the X-band radar and the division of work between the Master and OOW. The investigation was not able to determine the sequence of events on the naval vessel.

- In this instance, the bridge teams of both vessels made the classic mistake of not sufficiently reducing speed to give more time to assess the situation and/or increase the CPA. In any event, given the restricted waterway no other manoeuvre was even possible in this situation.
- In restricted visibility the rules of the road are clear. Rule 19 applies, stating: Every vessel which cannot avoid a close-quarters situation with another vessel forward of the beam, shall reduce speed to minimum steerage. If necessary take all way off and in any event navigate with extreme caution until danger of collision is over.

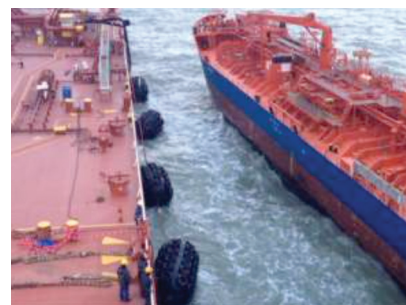
The STS supervisor first requested the discharging vessel to heave up five shackles and remain anchored with four shackles in the water. Unmooring then commenced. Within 10 minutes the receiving vessel started moving away from discharging vessel using her bow thruster and main engine. When the distance between the vessels was about 15-20 metres, the STS supervisor thought that the bow thruster of the receiving vessel was sucking a fender rope, so he stopped the thruster. Within seconds, the prevailing current caused the bow of the receiving vessel to drift towards the discharging vessel. The two vessels came into slight contact.

The unmooring manoeuvre was suspended and the discharging vessel was instructed by the STS supervisor to heave up her anchor fully. Once the anchor was retrieved, the unmooring operation was resumed underway and the vessels successfully separated. Except for paint scratches, no damage or deformation to vessel's side shell was observed.

- Weather conditions were optimum, and as such the unmooring operation could have been carried out safely with both vessels underway – which is how it was accomplished after the incident. A well-coordinated STS unmooring while underway gives more 'leverage' over external forces such as current.
- Fenders may be secured on either vessel, but contacting an unprotected portion of the hull is less likely if the fenders are rigged on the manoeuvring ship.
