# Mariners' Alerting and Reporting Scheme

MARS Report No 346 August 2021

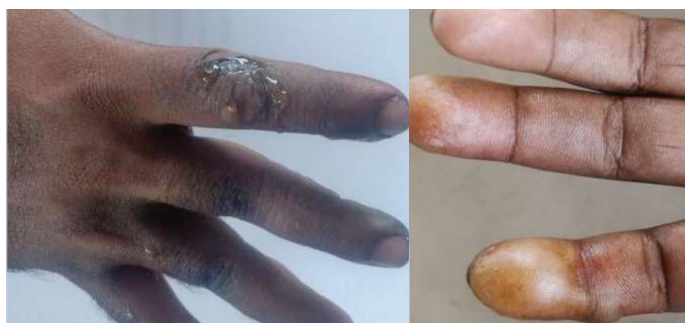
→ Two engine room crew were attending to the main engine fuel backwash filter alarm. They suspected the problem was a clogged pipe or air trapped in the line to the differential pressure cell. As one crew slackened the copper pipe ferule connection to purge the line, the pipe came free, releasing hot fuel on his hands. The victim was wearing cotton gloves, which became soaked with hot oil. It was later observed that the skin on his thumb was peeling off and blisters had developed. First aid was administered and he was sent to a shore facility at the next port for followup medical care.

The company investigation found, among things, that the system being worked on had not been isolated and vented to release the pressure.

- Proper isolation and lockout ('lockout/tagout', LOTO) must be completed before carrying out maintenance on any equipment. Ask yourself 'Is there any potential energy in this system?'
- Work permits, properly completed before the task begins, are the basis for safe and successful outcomes.
- Cotton gloves are not the best protection against work injuries.

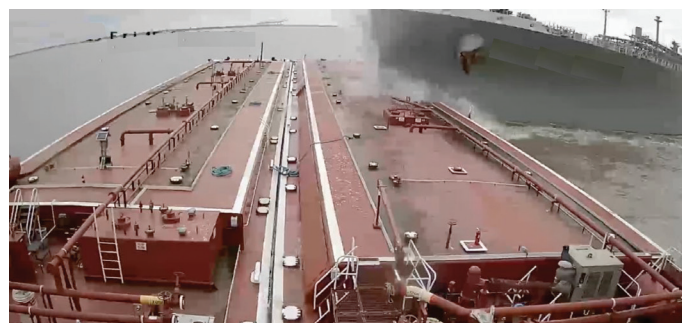
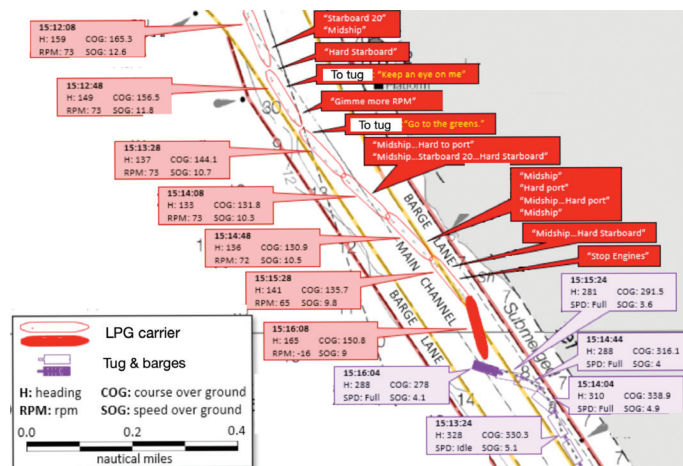
The tug Master complied and gave full port rudder, but within minutes the LPG vessel's bow struck one of the barges midship on the starboard side, penetrating the double hull and breaching two cargo tanks in that barge. The force of the collision capsized the second barge although no tanks were breached.

The official investigation found, among other things, that the combined effect of the speed of the LPG vessel passing another large vessel in the asymmetrically shaped channel resulted in an uncontrollable sheer to port by the LPG vessel, initiating the chain of events that led to the collision.

- Research on hydrodynamic interaction indicates that if the speed of the ship near a bank is too high, the rudder may be less able to cope with the forces induced and control will be lost.
- Proceeding at full sea speed in a restricted channel not only increases the risks of an uncontrolled shear due to hydrodynamic effects, but leaves the mariner with few options to mitigate or control the situation.

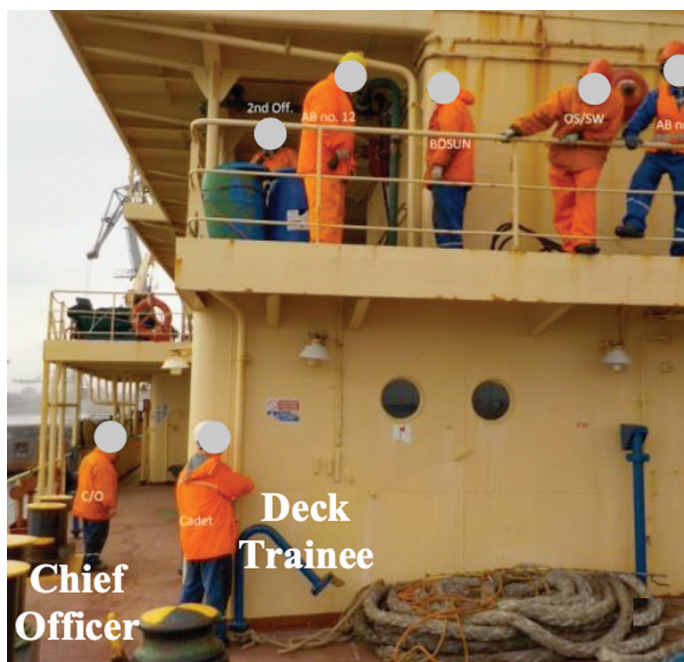
Simulation of the event

Three more deck crew arrived on deck 1 to assist. Some ropes were brought on board and untangled, with some crew working on deck 1 and the chief officer and a trainee on the poop deck. Suddenly, a large wave washed over the poop deck from starboard. Within seconds of the first wave, a second larger wave washed on board from the same direction. The two crew on the poop deck were swept overboard.

The official investigation found, among other things, that neither victim was secured to the vessel with a lifeline when the waves washed over the poop deck. Additionally, the crew members were not wearing lifejackets while working on the exposed deck in adverse weather conditions.

- Hindsight is always 20-20, but most vessels loaded to maximum draught are susceptible to breaking waves in heavy weather, even on the poop deck. Lifelines must always be considered for emergency deck work in heavy weather, as must lifejackets.
- Before undertaking an unusual or undocumented task, take a few minutes to do a risk assessment among the team members, even if only verbally.

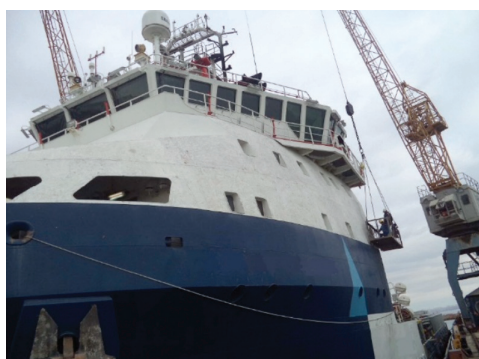
→ A vessel was in drydock undergoing hull painting. The painting area was accessed using the shipyard crane and a personnel basket. During this process it was observed that the workers in the basket were not using safety harnesses. After further questioning it transpired that neither the basket nor the fall arrest equipment had valid test certificates.

Uncertified basket

The job was stopped and the shipyard was required to correct the situation. Relevant certified equipment was then provided.

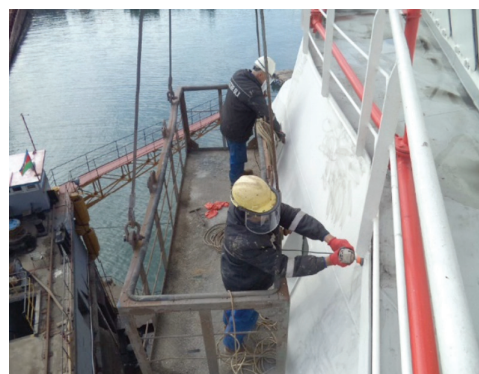
Working at height without a safety harness

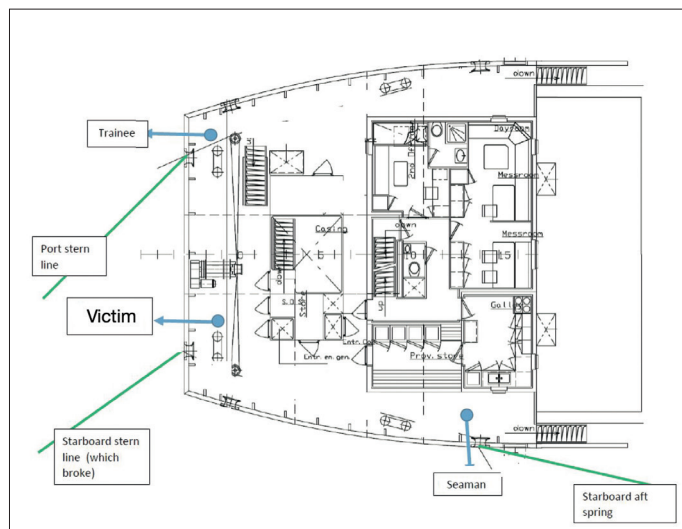
As the AB worked the aft spring to give it slack, the two unsecured stern lines started running quickly into the water. The AB stopped the starboard stern line from running out but due to the sternway of the ship, this line become entangled in the propeller. It quickly came under tremendous tension and then failed. The AB was hit by the recoiling section of the mooring line.

- The mooring lines left loose on deck were a hazard, and were able to enter the water unhindered.
- The AB that worked the spring line had not taken sufficient rest hours prior to the incident. This may have influenced his actions and his supervisory role.

- Keeping a clean and unobstructed deck is a best practice that helps reduce risks.
- Communication is key during mooring. The bridge should immediately be advised of any situation that may escalate and cause negative consequences, such as a line in the water near the propeller.
