Mariners' Alerting and Reporting Scheme

MARS Report No 350 December 2021

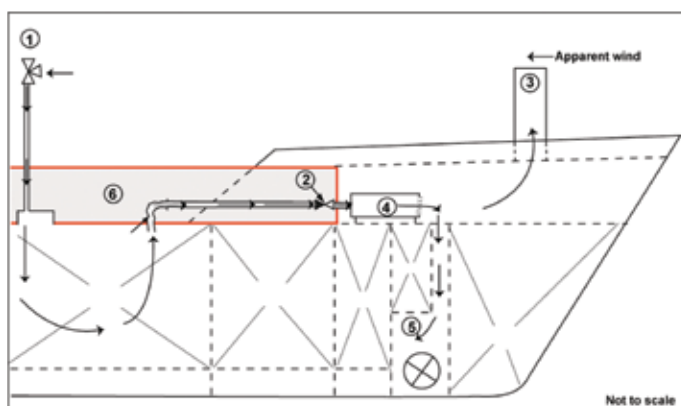
Migration of flammable vapours from cargo tank to bow thruster compartment

The analysis in the official report describes how, given that the forecabin door was open, the apparent wind across the vessel's bow had created an area of lower pressure in the forecabin. This, coupled with open PV valves, induced a flow of gasoline vapours from the cargo tank into the forecabin through the drying unit and the modified non-return valve, as shown in the diagram. The modifications to the non-return valve had not been approved. Once the heavier-than-air vapours passed through the tank-drying unit, they settled downward and into the bow thruster compartment. The vapours were probably ignited by an automatically controlled heating unit in the bow thruster compartment.

- The inappropriate practice of using the tank-drying equipment for cargo tank ventilation allowed the migration of explosive vapours into the bow thruster compartment.
- The modification of the double non-return valve reduced its effectiveness and contributed to the migration of explosive vapours into the forecabin and bow thruster compartment.
- With no formal procedures and training to mitigate the risks associated with tanker operations, the effectiveness of the vessel's safety management system (SMS) was reduced.

- Safety depends on training and good procedures. In this instance, there were no written procedures for safe tank venting and equipment designed for tank drying was being co-opted for tank venting.
- Any modifications to equipment, such as the double non-return valve in this case, should be vetted through the vessel's classification society.

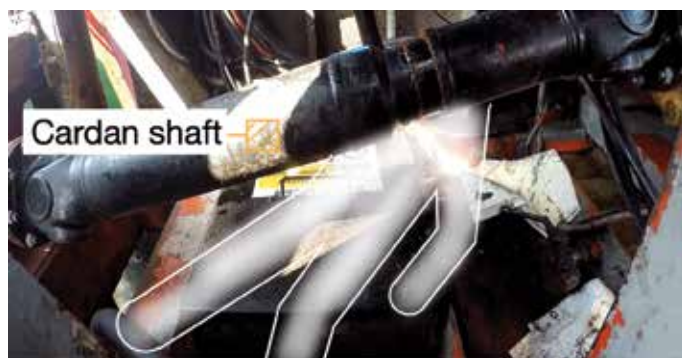
After helping the officer with an associated task, the Master returned to the bridge to inquire about progress with the tugboat. Suddenly, he heard a yell from the aft deck. He rushed back, finding the officer trapped under the cardan shaft. The officer had disconnected the lifting cylinder hose instead of the damaged hose, and the shaft had fallen down on him. The Master immediately searched for tools that could help release the officer. He tried to lift the cardan shaft using a strap and chain hoist, but without success. He then called for an ambulance, and, at the same time, got some persons on the quay to help him; a forklift truck and several crew members came from nearby ships. The forklift succeeded in lifting the cardan shaft, so the Master and another crew from a nearby ship could secure the shaft off of the victim.

Outline of victim under cardan shaft

- On small vessels, the reduced crew can be tasked with duties that go beyond their competencies. This can bring unintended consequences that, as with this case, can prove fatal.
- If there is an emergency the first priority is to raise the alarm and solicit help. In this case, although well meaning, the Master lost valuable time rigging a strap and chain hoist for an improvised rescue before calling for help.
- Some perceived urgent situations can be, upon calm consideration, less urgent than initially assessed. In this case the vessel was nonetheless in a safe position near the berth and there was no need to undertake a hasty repair of the starboard propulsion.
- Mariners are often endowed with 'can-do' personalities; they wish to fix the problem in quick order. Resist this temptation and make a calm assessment of the situation before acting.

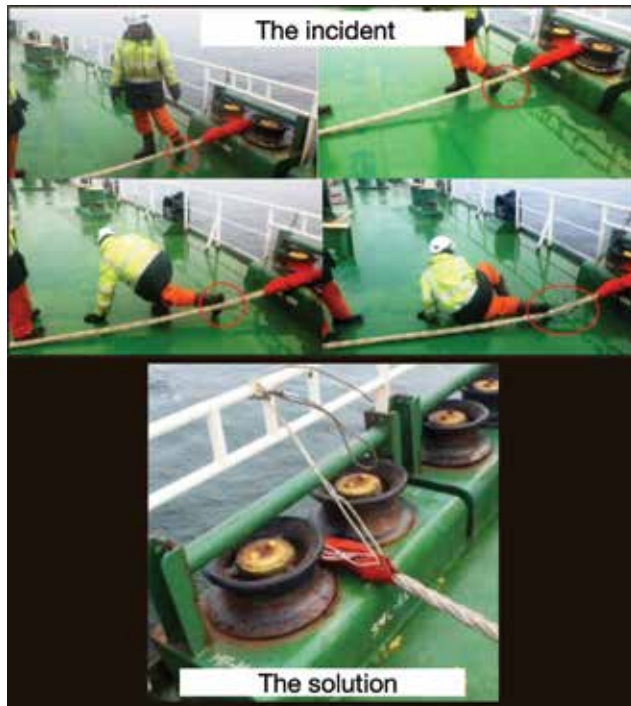
→ A vessel was in the process of berthing. A crew member carrying out his work at the forward berthing station tripped over the lanyard securing the spring line's chafing sleeve to the vessel's railing. The victim did not think he was injured but, when trying to stand he felt severe pain at his left hip.

- Even the most minor incident can lead to serious consequences. All incidents should be investigated and opportunities for risk reduction sought.
- A clean and unobstructed deck is a safe deck. In this case a small lanyard left adrift on the deck was enough to cause a repatriation.

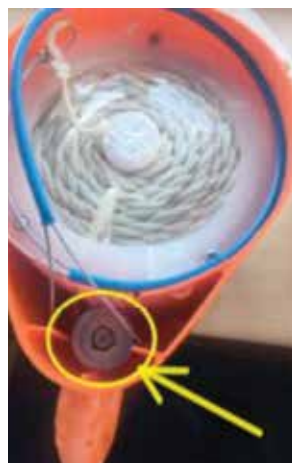
→ An officer was tasked with pyrotechnic inspection and replacement. While undertaking the rocket replacement in the Line Throwing Device (LTD) he found that the previously installed rocket had been inserted upside down, which would have certainly meant an improper activation if needed. The same was found in two other LTDs on board.

It was found that the LTDs had been delivered in this state but this defect had not been discovered during inspections.

- The inspection of even the most basic equipment might lead to surprises. This task must be taken with the utmost seriousness as even manufacturers can make mistakes.

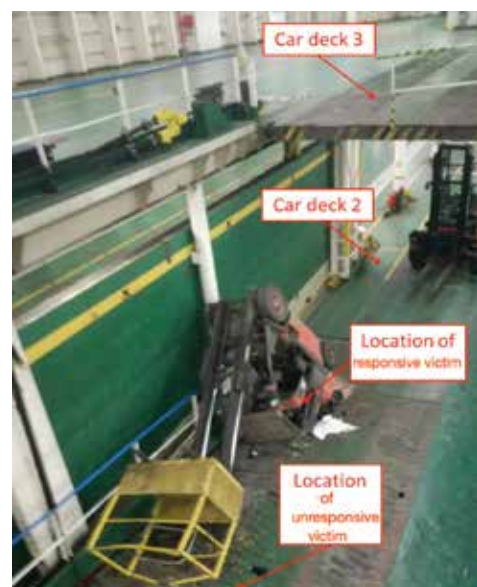
Later on, while most crew were at coffee break, a loud bang was heard. Various crew members went towards car deck 2 to identify the source of the sound. The securing barrier on car deck 3 was found broken, and the forklift had fallen from car deck 3 onto car deck 2. The forklift was lying overturned on the ramp with a crewmember inside the forklift cabin. This crewmember was injured but responsive. Another crewmember was found inside the overturned forklift basket and he was unresponsive.

The crewmember that was in the forklift cabin later recovered, but he did not remember events from the accident. The company investigation found that the forklift had been operated with the victim in the basket and the forklift mast extended to the top. It was also found that the crewmember operating the forklift truck did not have the training or authorisation to operate the truck. There was no dedicated procedure in the company's SMS providing requirements for the access and operation of the forklift. Neither was there any specific procedure for maintaining, recording or managing crew members' qualification and experience for operating a forklift truck.

- Forklift truck operation is an inherently high-risk operation. Operators of this equipment should have proper training and follow procedures. According to the website McCue.com, on average 95 people are seriously injured in a forklift accident every day and 1 person is killed in a forklift accident every 4 days in the United States alone (land-based use).
- Effective administrative and access controls must be maintained to ensure that only authorised and trained personnel can operate such equipment.
