Mariners' Alerting and Reporting Scheme

MARS Report No 344 June 2021

MARS 202128

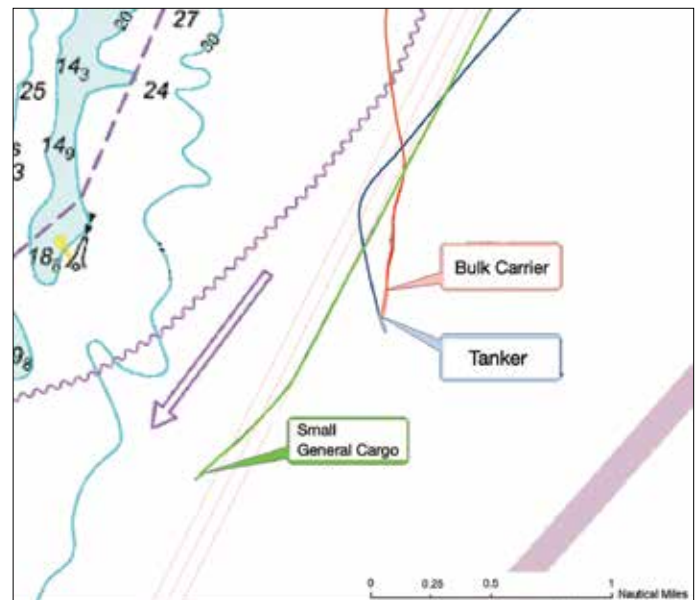
Without a visual check for sea room astern the tanker's Master ordered hard port helm to begin the full turn. He also increased the engine setting to slow ahead. The bulk carrier was now only 0.42nm off the tanker's port quarter.

Soon, the tanker's lookout saw the bulk carrier, now close on their port quarter. He alerted the Master just as the OOW questioned the Master's intention to complete a full turn with the bulk carrier astern. The Master was surprised to see the bulk carrier so close, and reduced the engine setting to dead slow ahead while ordering the helmsman to stop the swing to port. The Master then ordered 10° of starboard helm

Meanwhile, the bulk carrier's Master was also surprised to see the tanker altering rapidly to port and across his vessel's bow. The two vessels were now just 655 metres apart when the tanker steadied on to a heading of 172°. Unsure of what the tanker's Master intended to do, the bulk carrier's Master ordered the helm hard to starboard. As the distance between the vessels continued to reduce, he changed his mind, first ordering the helm hard to port and then finally hard to starboard.

The vessels were now too close and a near parallel collision was inevitable. The general alarm was sounded on both vessels. After contact, the vessels remained immobile alongside each other for about an hour. Then, the tanker manoeuvred away. Neither vessel required assistance to make for a port of refuge.

The official investigation found, among other things, that the tanker Master's reaction times and decision-making ability were possibly reduced, as indicated by his omission to check for sea room before the port course alteration. The contributing factors that lead to this reduced ability were the time of day and possible fatigue of the Master. This was his first transit of this high traffic area, so mental loading may also have played a role.

- The person with the con of a vessel should listen intently to any critical communication with other vessels, even if this task has been delegated to another bridge team member.
- Long-range scanning of vessel movements via radar is preferable to last minute VHF communication for collision avoidance.

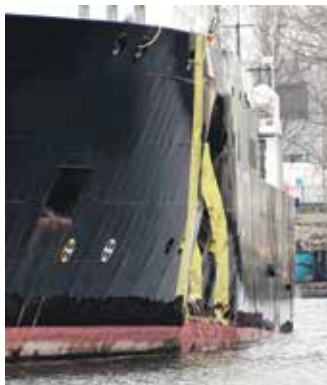
At this time the mother ship continued on autopilot. The captain was still preoccupied with administrative tasks. At 04.12, the mother ship collided with the starboard bow of the bulk carrier. Several crew members suffered minor injuries; there were no injuries aboard the bulk carrier.

Damaged PSMS

- As mentioned in many past MARS lessons learned, darkness changes everything! It is hard to imagine this accident happening in daylight and good visibility. When in darkness, re-double your attention.
- As also mentioned in many past MARS lessons learned, being preoccupied with other tasks instead of navigating your vessel changes everything. Put distractions and other tasks away when navigating your ship.
- Making assumptions about the movements of other vessels, even in apparently clear-cut circumstances, can have negative consequences. In this case, the bulk carrier’s crew and pilot assumed the PSMS would stay clear, but at no time did they confirm this with the PSMS via VHF communication.

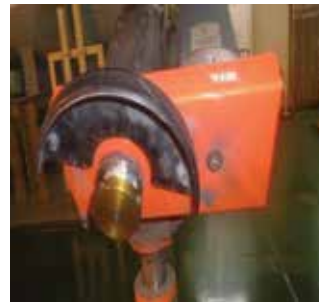
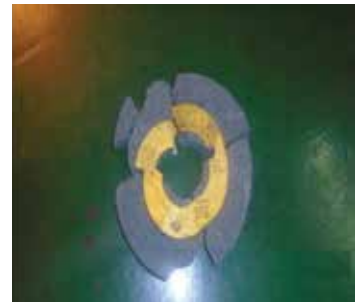
→ An electrician was assigned to repair an electrical deficiency in the grinder used for main engine exhaust valve maintenance. Following the repairs, the grinding stone shattered during final checks and testing. One of the pieces hit the electrician's forehead.

The company investigation revealed that the electrician had worn a safety helmet but it had not been secured with the strap. The flying projectiles had hit the helmet and dislodged it, allowing injury. A face shield had not been worn either.

- Grinders turn at high speed and even if they have their own built-in shields, crew should always wear face protection when using them.
- Grinding wheels and discs can shatter – be aware of this and use PPE appropriately.
