Mariners' Alerting and Reporting Scheme

MARS Report No 347 September 2021

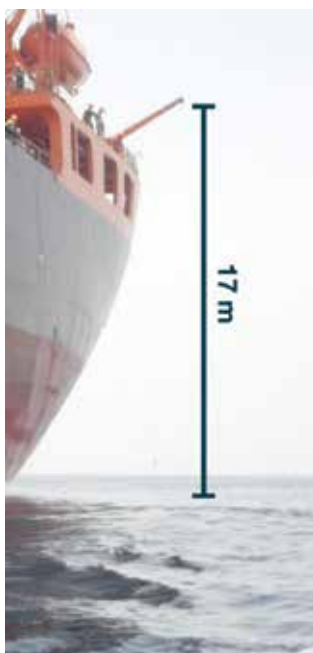
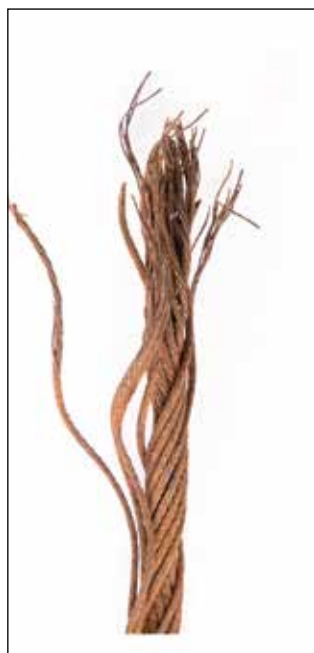
→ In calm seas a vessel was stopped while underway to allow crew to undertake boat drills. While the lifeboats were tested, the rescue boat was launched and manoeuvred close to the ship by a three person crew. The rescue boat trials lasted for about an hour before the crew brought the boat alongside for recovery. Once the hook and painter line were fastened, the crew in the boat sat on the floor in a stable manner and the hoist was started. When the boat reached the boat deck, the winch was stopped. Suddenly, the wire failed and the boat fell 17 metres, hitting the water upright. The engine was torn off its foundation, the

bottom hull cracked, and the boat slowly drifted alongside the ship's port side. All three crew members were still in the boat, but seriously injured. The alarm was immediately raised.

The official report found that the rescue boat davit's wire rope parted because it was corroded to the extent that its load bearing capacity was exceeded when the rescue boat was hoisted. However, the parting of the wire rope was an 'accident event' which could not in itself explain why the rescue boat system failed. Even though the company's Planned Maintenance System (PMS) instructed the officers to inspect and maintain the wire rope, they did not act upon the deteriorating condition of the wire rope. Neither did any of the other officers who continuously inspected, maintained and operated the rescue boat system even when the wire rope was readily visible.

The reason the poor condition of the wire rope was not recognised earlier was a combination of at least three factors:

1. The manufacturer's manual and PMS did not specify how to assess the condition of the wire rope.
2. An absence of training in assessing the wire rope's condition.
3. The PMS activities were compartmentalised. This meant that in practice only one person was assessing each component. All these factors were compounded by the thorough examination performed by service providers which gave the officers a blind trust in the system as a whole.

- Assessing the viability of a wire rope is not an intuitive process. Some wire rope may appear good but be unsafe while others may appear outwardly poor but still be very good. Special training is needed to properly inspect wire rope.
- A wire rope inspection checklist should be used for this task and the checklist should have viability criteria listed as a reminder for the person doing the inspection.
