Safety Alert

SA 014

Cargo Damage due to Water Ingress from Ballast Tanks and Bilge Lines

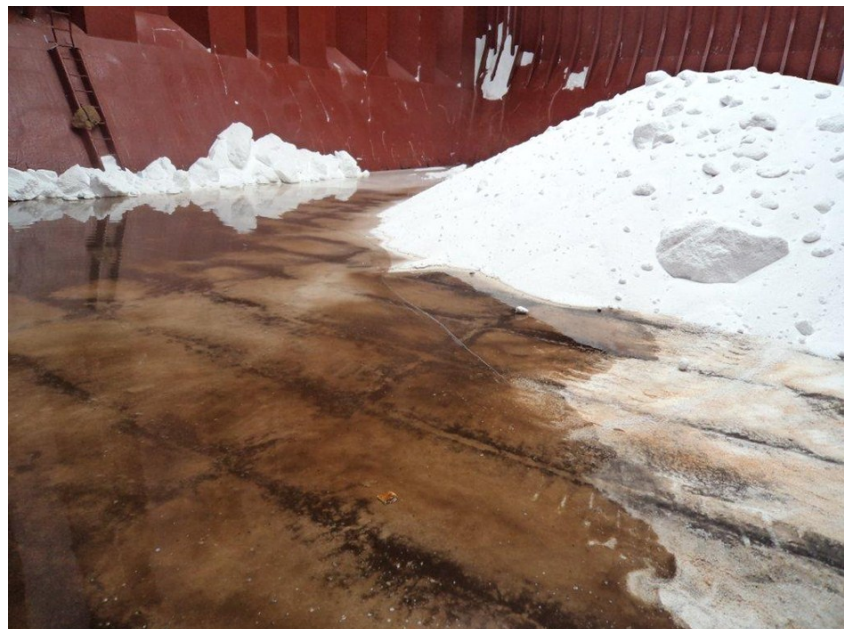
- Damage to the hold structure. This may be caused by cargo operations, for example, due to grab damage to tank top plating or hold pipework on vessels carrying dry bulk cargo. Similarly, container vessel tank tops may be damaged by containers which are landed heavily or if lashing material becomes trapped between tank top and the container base.
- Severe corrosion of ballast tank steelwork. This may involve plating where localised corrosion is so severe that holes have appeared, or ballast tank air and sounding pipes in holds where the blind side of pipework close to the adjacent steelwork has corroded

This fertilizer cargo was damaged by sea water migrating from an adjacent holed ballast tank

cargo holds in question are empty. The ballast tank is overflowed to deck and the cargo holds adjacent to the tank inspected for leaks. However, such a practice only confirms that the tank is not leaking at the time of the test. It is therefore recommended that, as far as is safe and practicable, ballasting operations are only undertaken when the adjacent cargo holds are empty of cargo, recognising that this may not always be possible due to operational reasons.

If a ballast tank manhole within a cargo hold has been opened for a routine inspection, to carry out maintenance or while in dry-dock, the manhole cover should be refitted carefully on completion so that the tank is ready for use. Checks should be made to ensure that sealing arrangements are free of debris, that the gasket is in satisfactory condition and renewed if necessary, and that all nuts and bolts are in place and correctly cross-tightened in order to achieve a watertight seal. Provided no cargo is present in the hold, it is recommended that the tank is then checked by means of hydrostatic testing at the earliest opportunity to confirm that the manhole cover does not leak.

Periodic hydrostatic testing of ballast tanks should also be considered as part of a vessel's planned maintenance system, conducted at suitable intervals when the holds are cargo free. In addition, if a sounding or remote monitoring of a ballast tank reveals an unexpected reduction or increase in the tank's contents, a thorough investigation should be carried out to ascertain the cause of the change.

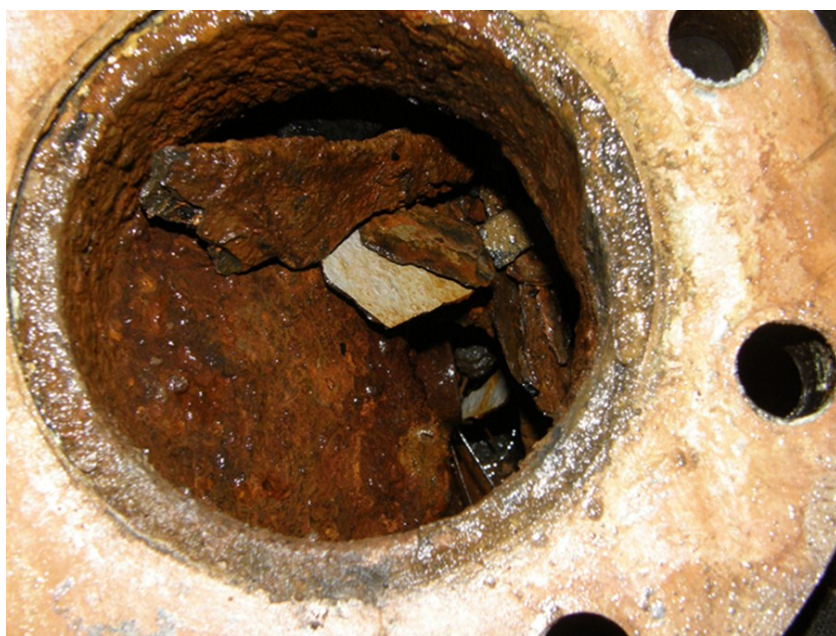
Cargo hold bilge systems are fitted with a non-return valve on each bilge line, normally within the bilge well above the strum box/strainer. The non-return valve can become blocked, either by cargo residue or by rust or debris such as rags, preventing it from closing properly. Non-return valves can also seize open or partially open; a lack of an audible clanking of the

non-return valve in operation should be investigated. If the screw down valve between the bilge line and the bilge pumping system/eductor is not closed and bilge/general service/ballast pumps are subsequently operated, sea water may flood back along the bilge line, past the non-return valve and into the cargo hold.

Rust and debris blocking this bilge well non-return valve allowed sea water to migrate into the hold during ballasting operations, causing cargo damage

It is recommended that the inspection, maintenance and testing of cargo hold bilge line non-return valves are incorporated into the vessel's planned maintenance system, including checks for backflow past the non-return valves when bilges have been pumped dry. Non-return valves and bilge line isolation screw down valves should also be opened periodically and inspected for obstructions and the build-up of cargo residues to ensure that they remain effective. Where bilge suction lines pass through ballast tanks, the pipework should be checked for excessive corrosion during routine ballast tank internal inspections.

In order to prevent debris and cargo residues from entering the bilge line and affecting the operation of the non-return valve, a strainer/strum box should be fitted to the end of the bilge suction pipe. When carrying dry bulk cargo, suitable protective measures should be taken to prevent cargo migrating past the bilge well plate into the bilge well. When cleaning holds after the discharge of dry bulk cargo, bilge well plates should be removed and all traces of cargo residue and debris cleared from the bilge well.
