MARS – Lessons Learned

MARS Report No 374 December 2023

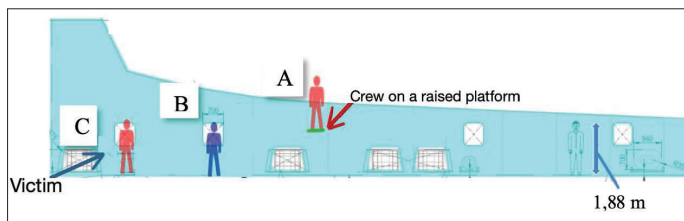
In order to set the berthing lines with their appropriate heaving lines, the deck crew were passing the heaving line outboard from position A, where the deck crew was standing on a platform due to the high bulwark, to position C, via position B. A gaff was used to catch the line through a bulwark port at position B. The line was then passed outboard to position C. A deck crew at position C had his arm out of the bulwark port holding a gaff to catch the heaving line.

A few seconds before the line passing manoeuvre began, one of the bow thrusters came offline due to an overpower surge. There was no alarm to warn the bridge team of this situation. The ferry was quickly pushed back to the berth, and the bridge team, realising the situation too late and preoccupied with the manoeuvre, gave no warning to the deck crew, who were unaware that the ferry was closing on the

berth. The ferry's starboard side struck a berth fender at the level of the bulwark port at position C just as the deck crew had his arm outstretched and outboard. His arm was instantly severed.

The victim was treated immediately for profuse bleeding. Within minutes the vessel was re-berthed and the victim sent ashore for professional medical attention. The official investigation found that, among other things, the ferry, which was a new build still under guarantee, had suffered numerous bow thruster and electrical problems since beginning service a few months prior.

- Following the accident, a task analysis made it possible to establish a work method which eliminated the risks due to the use of a gaff outboard.
- Everyday practices, when conditions are benign, can hide hazards in plain sight. Take the time to re-analyse current work methods using the 'what if' risk assessment methodology. Can risks be further reduced by eliminating hazards or questionable procedures?
- New vessels can be subject to a 'breaking in' period where numerous minor or even major anomalies are discovered. These should be corrected as soon as possible to avoid unwanted negative consequences.

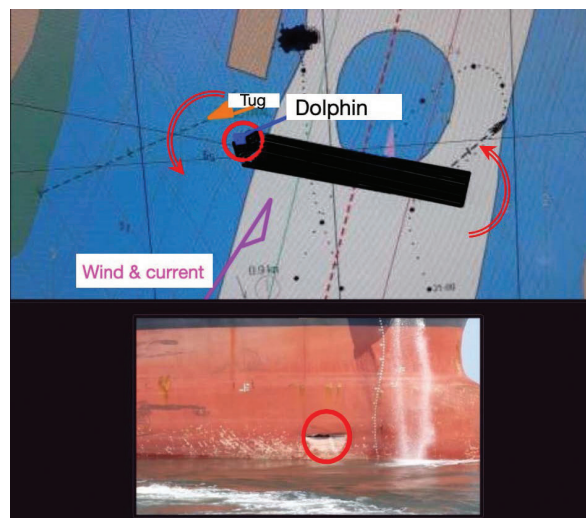
The tugboat aft was ordered to move to vessel's starboard bow to better assist in the rotation. With the tug pushing at the starboard bow, the vessel was now moving aft with a Speed Over Ground (SOG) of 2.4 knots. Soon, the vessel had turned about 60° to port, but the current and wind were moving the vessel to the north. The main engine was set to half ahead while rudder was hard to port.

As the vessel achieved approximately 90° of the turn, it was reported to be 10 metres from a dolphin on the starboard bow. The tug was at full power, but could not control the vessel's set toward the dolphin and had to abandon its position for fear of being crushed. The vessel's main engine was set at full astern, but the starboard bow brushed against the south corner of the mooring dolphin. Within minutes the vessel completed the turning manoeuvre and commenced the outbound passage to the anchorage, where damage to the hull was observed.

- In a very restricted waterway and with wind and current conditions that made for a complicated 180° turn, the use of one tug is, in retrospect, a hazardous decision.
- Only one tug was available in this port, so the hazards were 'normalised' by the Master and pilot as 'acceptable'.
- Plan a manoeuvre beforehand and think about the forces acting on your vessel. In this case the vessel had to come 180° after leaving the berth and at one point was perpendicular with the current in a restricted channel. The tug could not overcome the forces acting on the hull pushing it to the North.
