MARS – Lessons Learned

MARS Report No 368 June 2023

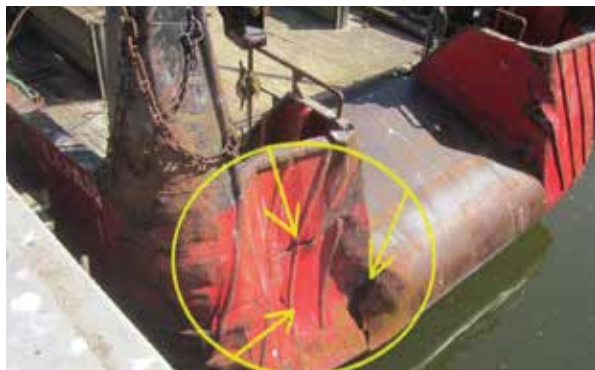
Soon, with the distance between the vessels decreasing and no response from the cargo vessel, the fishing Master realised he must take avoiding action. He put the helm hard to port and increased engine power to full ahead, even though this put the fishing gear at risk of damage. Nonetheless, the cargo vessel's bow hit the aft superstructure of the fishing vessel, causing damage across an area of 1.5m².

Collision damage to fishing vessel

- Never leave the scene of a collision until confirmation has been received from all concerned that everything is under control and pertinent information from both vessels has been exchanged.
- While not specified in the official report, it can be assumed that the lone watch keeper on the cargo vessel was not keeping an effective lookout for other vessels. The course and speed of the cargo vessel never changed and the watch keeper never responded to the VHF calls from the fishing vessel. A power driven vessel underway must keep clear of a vessel engaged in fishing.

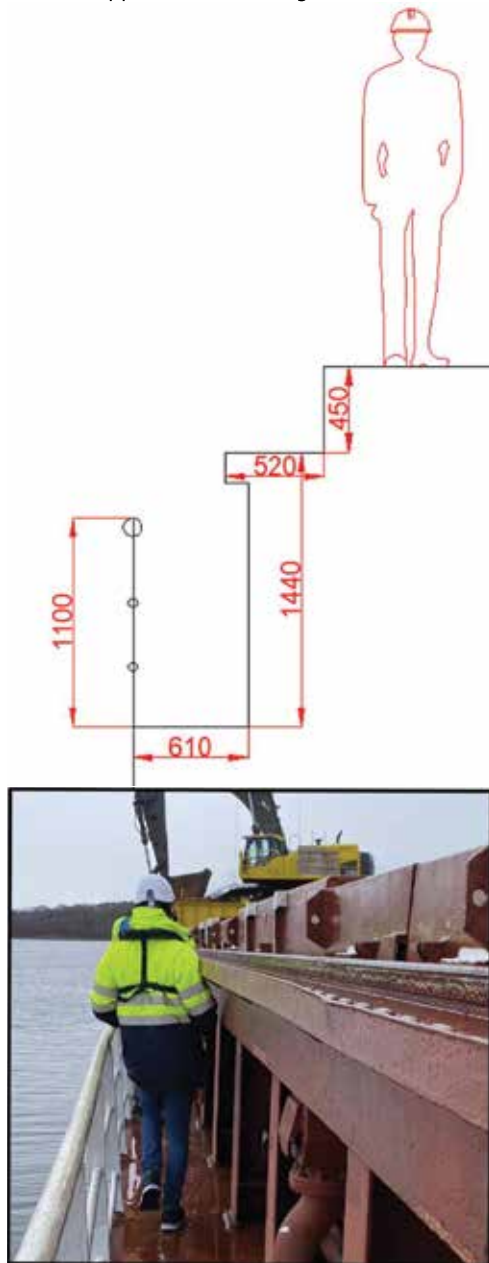
He first climbed down onto the rail track, placing his right arm on the hatch deck for support. He then brought his left foot down, closer

to the railings, but his foot slipped and he fell across the railings and overboard.

The investigation also found, among other things, that the vessel's design still represents an inherent residual risk even though, following the accident, the company introduced a procedure to reduce the risk of falling overboard (i.e., only dedicated access routes shall be used to and from the hatch deck). The passageway along the main deck is narrow and the height of the railings is not sufficient to prevent the possibility of a fall from the hatch deck.

- The shipping company plans to increase the height of some railings in the areas the deck crew habitually use to access and leave the hatch deck, other than the approved access areas. The measure is intended as additional security in the event that crew do not comply with the procedure of using the approved access area (see comment below).

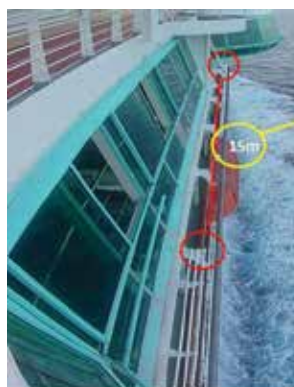
Further discrepancies included the lack of adequate external securing anchors and dedicated catwalks in the proximity of certain windows. This resulted in the deck crew having to connect to an improvised anchor point inside the frame of the window and walk on the 'upper basket rail'. This arrangement also shortened the available reach of each worker so a temporary solution using strops was necessary. The strop had to be looped inside itself to provide an anchor point, increasing the risk of confusing the secure end of the strop with the loose end.

15m section with no dedicated catwalk or secure anchor rail

- Working overboard without wearing an appropriate flotation device is extremely hazardous. Compact floatation devices that inflate upon contact with water could be more appropriate for working at height than voluminous floatation devices that restrict movement and could cause injuries when falling from tens of metres.
- Adequate resources should be made available to ensure experienced personnel oversee the maintenance procedures, ensuring all safety procedures are implemented and verified.
- When working at height, appropriately designed structures and equipment shall be in place to support and secure any individual.
