MARS – Lessons Learned

MARS Report No 386 December 2024

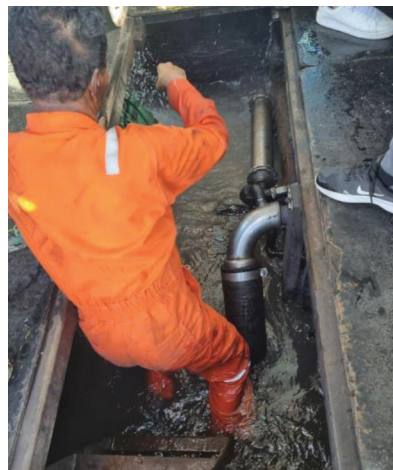
Water flooding the service boat

As the service boat was making way, water started flooding into the machinery space. The service boat crew tried to find the cause of the flooding in order to plug the leak, assisted by some vessel crew. Their efforts were unsuccessful, and the water level continued to rise. The service boat crew reported the incident by radio, and it was decided to abandon the service boat into a liferaft. The service boat sank a few minutes later.

- Marine emergency duties are a useful skill; you never know when you may need them.
- Be aware of your surroundings and keep your cool.
