MARS – Lessons Learned

MARS Report No 390 April 2025

Hazard in plain sight causes catastrophic injury

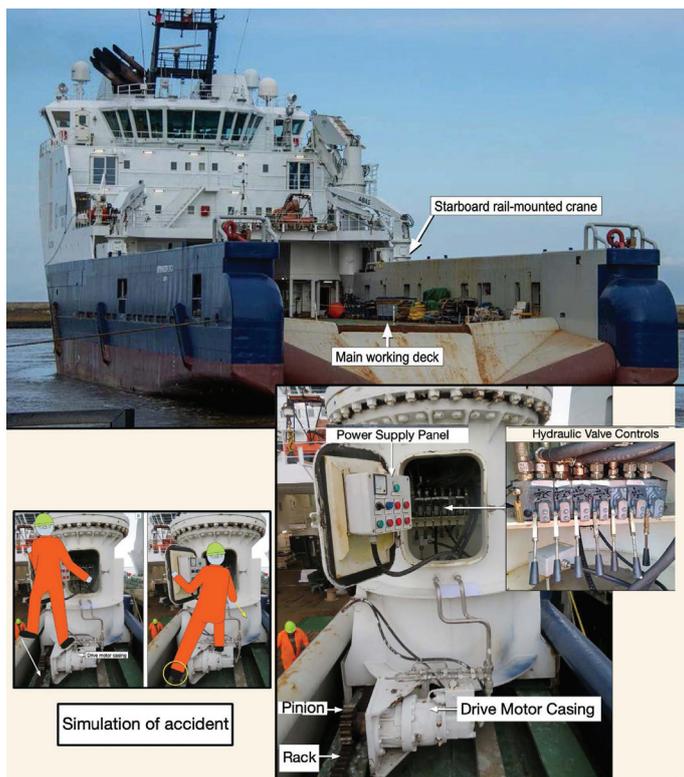
After repositioning two loads on the main deck, a third lift was initiated. In order to see both the fitter and the load to be moved 4m below on the main deck, the officer stood with his left foot on the inboard bulwark and his right foot on the crane drive. At one point, he shifted his left foot from the bulwark to the crane's travel rack. He felt something pulling at the left leg of his overalls, which unbalanced him.

He held onto the crane travel lever for stability, but this caused him to unintentionally pull it further backwards, which increased the speed of the crane's traverse on the rack, and his left foot and leg were dragged into the rack and pinion drive. He let go of the travel lever, which stopped the crane.

The investigation found that the crane manufacturer's operations manual, which was available on board, stated that the local controls in the crane pedestal were for emergency use only. Normal operation was to use either the bridge control station or the crane's remote-control unit. The company's Safety Management System (SMS) made no reference to ship-specific operating instructions as there were none. The practice of operating the crane with no guardrails or restraints while working at height, and near the unguarded rack and pinion gearing, was a clear sign that the process was flawed. The crew indicated that they had the freedom to challenge on board practices, but they did not raise the issue of the operation of the cranes using the local controls as they considered it 'normal'. This demonstrated not only an ignorance of the manufacturer's instructions but a certain blind eye to unsafe acts or unsafe conditions.

- Why is it so easy to see a hazard after an accident? Seeing hazards where you habitually work is not effortless – you have to work at it. Open your mind and look 'with new eyes' at each task. Is there danger?
- Although generic instructions and practices in a company's SMS are a good first layer of protection, every vessel should have ship specific procedures that address the specific hazards of that vessel. No one knows the ship better than the crew, so get to work on your ship specific procedures

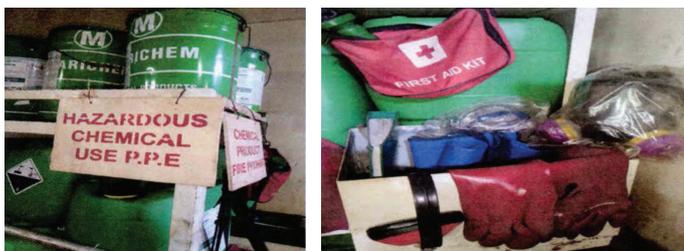
➔ An engineer was inspecting the chemical locker. He found that although there was a notice in place instructing crew to use proper Personal Protective Equipment (PPE) when handling the chemicals stored there, there was no easy access to specialised PPE equipment in place. He advised the Master and Chief Engineer and PPE was placed in easy access to the chemicals.

Before

After

- This is a good example of seeing a hazard that was in plain view for some time.
- Each chemical has its own specific risks. While specific PPE should be easily accessible, so too should an information matrix that shows what PPE must be worn for each chemical.

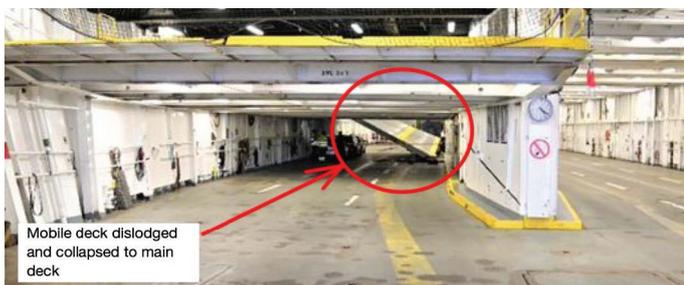
The crew member pulled in the locking wedges for the platform too early, an 'out of sequence' manoeuvre. This resulted in the platform falling freely for a short distance, putting high stress on the lifting cables and mechanism. One of the sheaves of the lifting cables was torn loose by the increased stress. The spacer plates that were supposed to hold the two steel plates of the line sheave together broke under the load. Now, there was nothing to hold the cables in place and one side of the mobile deck fell to the main deck. A car with a trailer was crushed and two people suffered minor injuries.

Mobile deck dislodged and collapsed to main deck

The investigation showed that there are no requirements for independent inspections of platforms for suspended (mobile) decks. However, requirements do apply to ramps that are defined as 'lifting devices'. Mobile decks have a similar technical design to lifting ramps and the risks associated with construction and use are similar. The disparate regulatory requirements for mobile decks versus lifting ramps do appear to be justified from a safety perspective. Similarly, there was no requirement for protection against wire breakage for suspended decks, whereas there is such a requirement for ramps.

The investigation also found that there were no technical measures to prevent the locking wedges from being pulled in before the platform had been raised. Finally, there was nothing to prevent people from being under the mobile decks during operation. This aggravated the consequences of the accident.

- There is no substitute for good training and complete familiarisation with the equipment being used. In this case the crew member's training in the operation of the mobile deck was less than adequate.
- Allowing people to remain under the mobile decks when the decks were being operated is a sign that better risk assessments are in order on this vessel and possibly others of similar design.

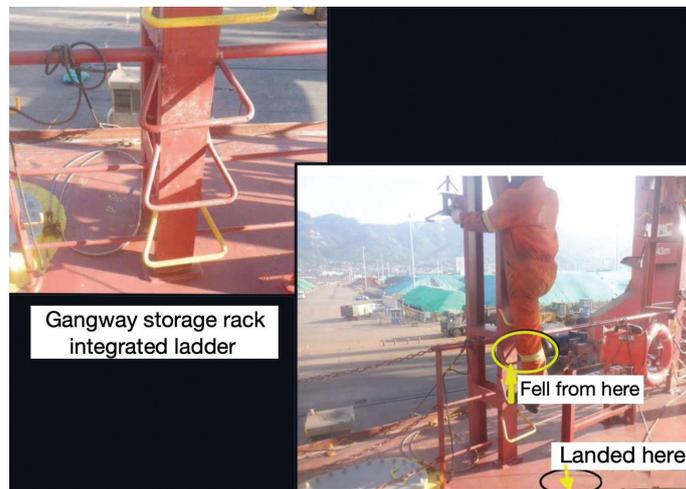
Gangway storage rack integrated ladder

A crew member accomplished this well-established routine, but while stepping down from the ladder he slipped from a height of about 1.2m, falling on the deck and landing on his right leg. The impact caused a fracture of the right knee.

Fell from here

Landed here

This common and well-practised procedure did not appear to be hazardous. Crew had accomplished this task innumerable times without incident. But after the accident, we can see that the integrated ladder, as installed, poses several 'safety traps'.

- The ladder gives good access to the gangway securing cleats but also gives a false sense of security. One hand is needed to hold yourself steady on the ladder, while one hand is free to work the cleat.
- The relatively low height of the access ladder adds to the false sense of security, after all, what can happen at such a low height? This accident proves that even a fall of 1.2m can cause a serious injury.

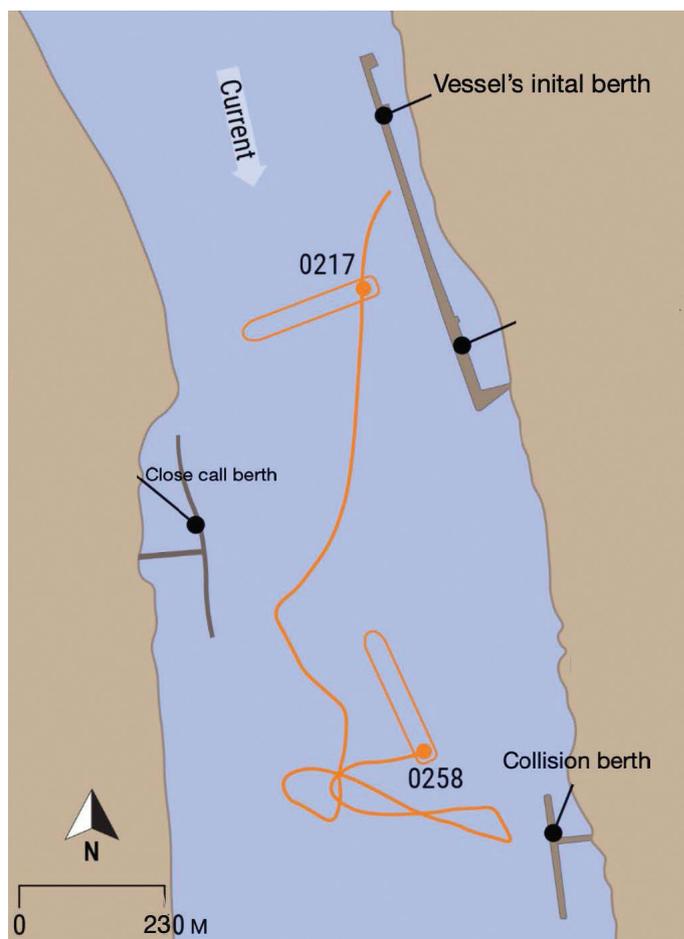
The investigation found that the probable cause of the breakaway of the bulk carrier from the dock was the bow coming off the dock during cargo loading, thereby exposing more of the vessel's underwater hull to the strong river current.

- The force of a current on the hull of a vessel increases in a non-linear fashion in relation to the current speed (ie to the square of the velocity). Beware of this hazard!
- It is important to ensure that berthing lines are kept well taut as a vessel loads and sinks lower. This increases the surface area of the hull to the current and hence the force acting on the hull.
- The increase in the force on the hull as the speed of the current increases is non-linear. A reduced UKC adds a multiplying factor to the resultant force. In this case, approximately 1.2X (source: Capt S S Chaudhari at <https://captsschaudhari.com/2020/07/02/how-do-you-go-about-anchoring/>)
- In such conditions, it is good seamanship to keep propulsion, thrusters, and steering systems on short standby and have anchors ready for immediate use, even if not required by the loading facility.
