MARS – Lessons Learned

MARS Report No 367 May 2023

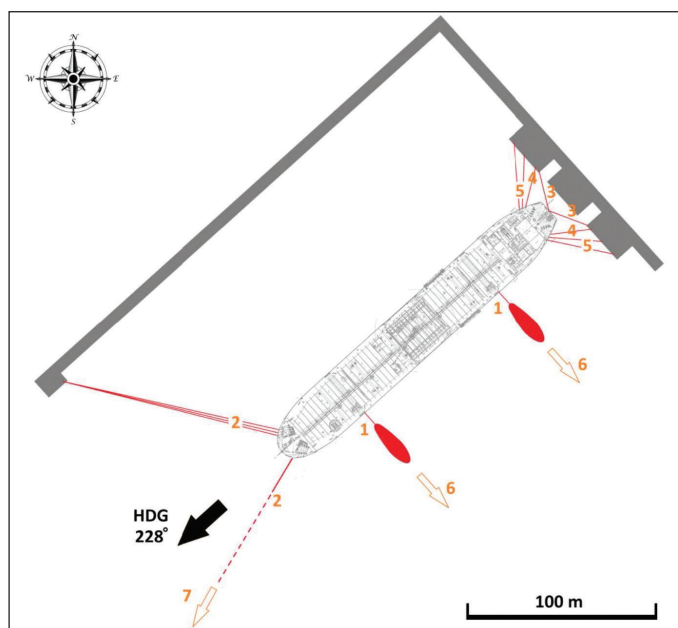
→ A tanker in ballast was departing berth under pilotage with the assistance of two tugs on the port side. The vessel was berthed 'Mediterranean style,' with lines running astern to the pier and to starboard on another pier in combination with an anchor on the port side, as shown in the diagram.

The official investigation found, among other things, that the stern line had probably failed at a tension that was less than the indicated amount on the Test Certificate, even though it was in good condition. Upon further investigation the Test Certificate was found to be non-authentic.

- Good plans can quickly fall to pieces if there is miscommunication or a change in planned sequence. In this case the aft mooring team was overwhelmed, as steps 4 and 5 of the original plan were combined into a single operation, and the tugboats started to pull too early.
- Acute situational awareness around lines under tension is a critical attribute to avoid bad consequences at mooring stations. Crew should be aware of snapback risks and have training on how to predict snapback areas depending on where a line may fail.
- Non-authentic documentation is not easy to spot. Efforts should be made to use credible suppliers and transparent supply chains.

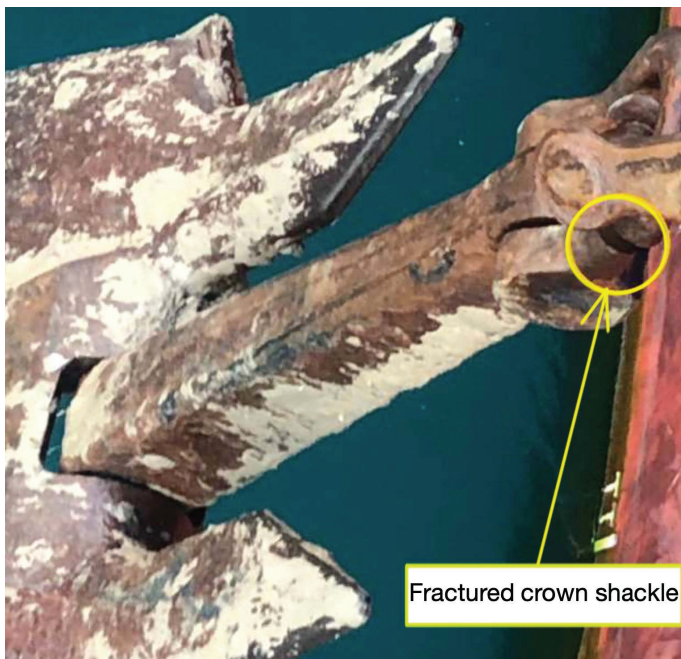
➔ The crew were heaving anchor on a tanker in ballast. As the starboard anchor came into sight above the water the officer noticed something was not right. He stopped the operation and informed the bridge team. Upon closer viewing it could be seen the anchor crown shackle was fractured.

The port anchor was released and arrangements were made to have the starboard anchor disconnected and a new crown shackle installed. The investigation could not establish a cause for the fracture. The crown shackle had been installed only five years earlier and was duly certified by a recognised classification society.

- Proper certification for ship's equipment is a first layer of safety. In this case, in contrast to MARS report 202322, the certification was authentic. But wear and tear will obviously decrease initial specifications and any hidden defects, if present, can become critical.
- Anchor gear is subject to brutal forces and good practice would include a close inspection of the chain and anchor on each recovery.
