# MARS – Lessons Learned

MARS Report No 379 May 2024

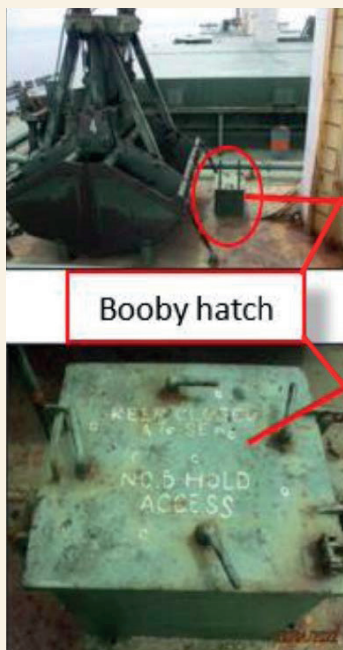
Four crew members were working to free the dog handles at one of the booby hatches. The booby hatch was open while they were doing this, and a disassembled dog handle fell down the hatch. One man climbed down to retrieve it. As he climbed back up with the retrieved dog handle, he lost consciousness due to a lack of oxygen, fell and landed on the coal cargo about 3.5 metres below.

The alarm was immediately raised and the crew mobilised to rescue the victim. An officer arrived at the booby hatch with an Emergency Escape Breathing Device (EEBD) hood and entered the cargo hold through the booby hatch ladder. Meanwhile two air hoses were being connected to the air supply in an attempt to supply air to the hold. The officer that had entered the booby hatch with the EEBD soon came out, saying that it was difficult to breathe and hot in the cargo hold.

- In an emergency rescue, the atmosphere of an enclosed space should always be considered unsafe unless confirmed otherwise.
- An EEBD should never be used to rescue a victim in an enclosed space. This equipment is only for escaping from a compartment that has a hazardous atmosphere and should not be used for entering oxygen deficient voids or tanks on board ships.

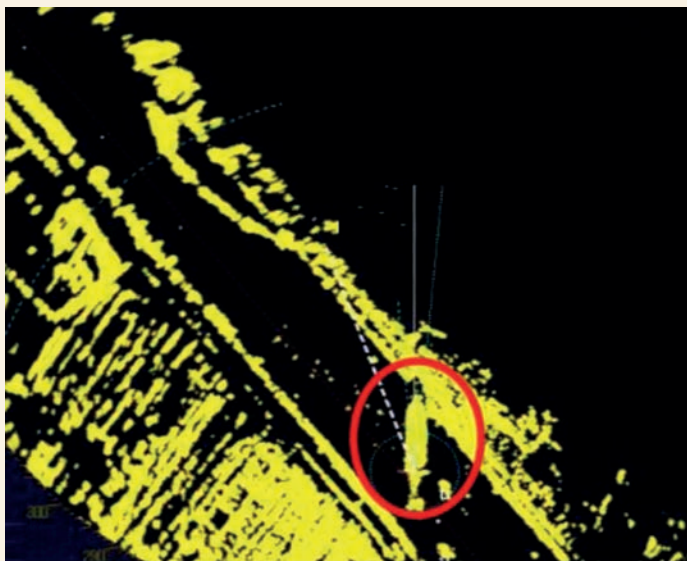
At one point, the pilot requested a course change to 002 degrees. The helmsman complied by easing the helm to midships for a brief instant. As soon as this was done the vessel took a strong shear to starboard; the helmsman rapidly applied 30 degrees of port helm in an attempt to stop the swing but this had no effect. The pilot ordered full astern, which slowed the vessel, but it continued to swing to starboard despite this and came crosswise in the canal before stopping.

Tanker crosswise in the canal

This is an almost identical incident to that of MARS202413. A vessel in a restricted waterway is experiencing bank suction aft due to being too close to the bank at a speed that is too high for the circumstances – even though it is only nine knots. The helmsman is using extreme helm to hold the desired course but as soon as this helm is eased or put to midships, the vessel swings inexorably to the opposite bank.

- Keen situational awareness and good communication are key to avoiding this situation. If extreme helm is required to hold the vessel steady in a restricted waterway, speed must be reduced as soon as possible before removing the helm. In other words, the pilot and OOW should be keeping an eye on the helm applications to better judge the strength of bank effect on the vessel.
- If the pilot and OOW are otherwise occupied, the helmsman should warn the pilot and OOW of the extreme helm application.

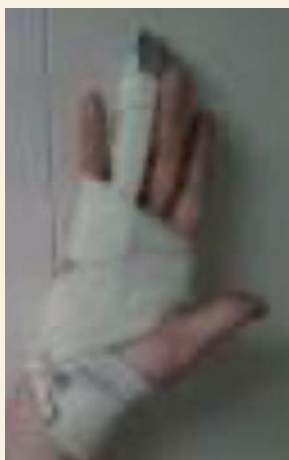
→ A tanker was at anchor near a port and some maintenance was being carried out. The electrician and two engineers were carrying out maintenance work on one of the engine room supply fans. As they attempted to open the fan cover, the electrician put his fingers between the cover of the fan and the impeller blades. The blades were still turning.

The victim suffered a deep laceration to the ring finger of the right hand, even though he was wearing gloves. The victim was sent ashore where surgery had to be performed and he was subsequently repatriated for recovery.

- Injuries are prevented by using adequate lock out/tag out procedures (LOTO). This appears to not have been the case in this accident.
- Keep your hands safe. Never use your hands to do a task that can be done with a tool.

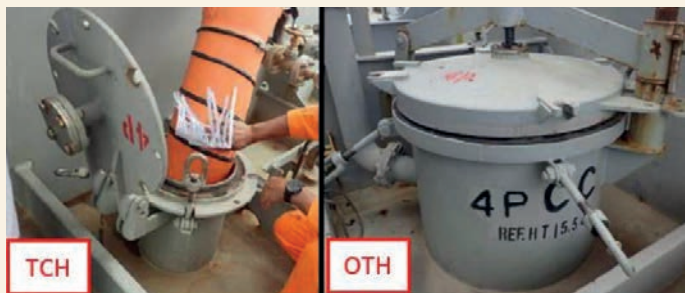
- After tank cleaning, the tank cleaning hatch (TCH) had been kept open and the oil tight hatch (OTH) was cracked open for the gas-freeing operation. This allowed gas vapours to accumulate on deck (open loop). This practice deviated from the company's Safety Management System (SMS) requirement that flammable and/or toxic gases from tanks could be vented only through the approved tank venting system (closed loop).

- The gas-freeing operation was conducted by directly connecting the portable air chutes to the tank cleaning hatches. The atmosphere of the tanks was not checked to verify gas concentration was within safe limits before connecting the chutes.

**TCH**  
Portable air chute connected to TCH

**OTH**  
OTH 'cracked' open
