MARS – Lessons Learned

MARS Report No 375 January 2024

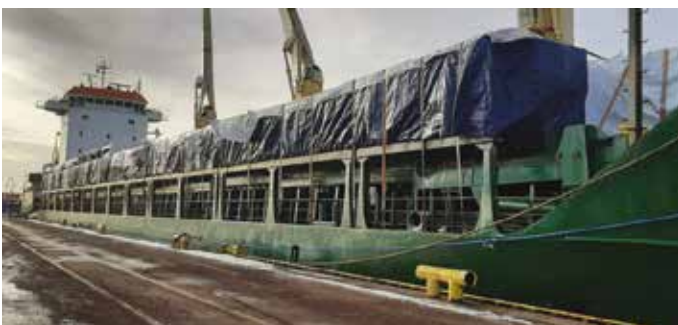
Several strong gusts of wind force person A under the tarpaulin and push him close to the edge

Person A is pushed over the ship's side and falls to the dock

The official investigation found, among other things, that time pressure may have played a role in the accident. The deck crew had noticed that the wind was increasing and they considered the working conditions to be risky. Yet, since an early morning departure for the next day had been announced, everyone was concentrated on 'getting the job done' during the evening.

Another finding of the investigation was that even though the work at height checklist had been completed (i.e. crew were to use fall protection equipment), this was not done in practice. The crew found it cumbersome to use a safety line during this type of operation.

- Time pressure is no reason to relax safety standards, as tempting as it may be to 'get the job done'.
- Safety leadership means ensuring good practices and that the vessel's SMS is always put into practice.
- A checklist mentality – where you consider ticking the boxes more important than the task they relate to – must be avoided. Remember, most checklists are the result of a risk assessment that was done to reduce harm. Only check 'yes' on something if you have actually done it!

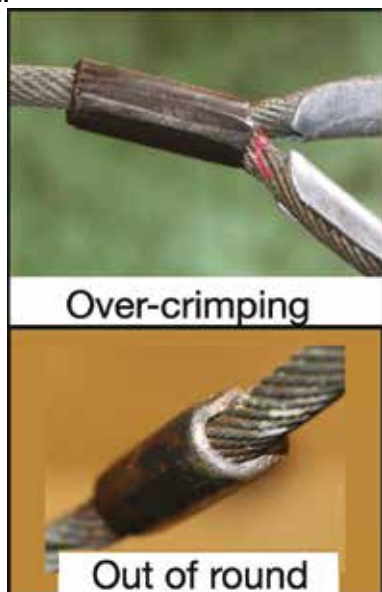
→ A vessel suffered extensive damage to equipment when a wire rope swaged splice termination failed. The investigation reiterated the importance of verifying the condition and appropriateness of wire rope terminations used in a load-handling capacity. This includes lifesaving appliances, cranes, and lifting slings, among others.

Improperly applied swaged fittings could result in unintentional damage to the wire rope, resulting in failure of the termination. Different types of fittings/end terminations might decrease

the safe working load (SWL) of the wire rope. For example, a swaged sleeve in a common turnback eye results in a 90% or better efficiency of the termination (i.e. 10% or less reduction in the SWL of the wire rope) when properly installed in accordance with manufacturer's recommendations.

- When renewing material such as wire rope and fittings, materials should be selected to match the specifications of the original equipment manufacturer.
- Visually examine wire rope terminations for abnormalities that may indicate improper installation such as out-of-roundness or over-crimping.
- Ensure that the termination type does not reduce the SWL of the wire rope below the minimum safety factor for the type of service.
