MARS – Lessons Learned

MARS Report No 366 April 2023

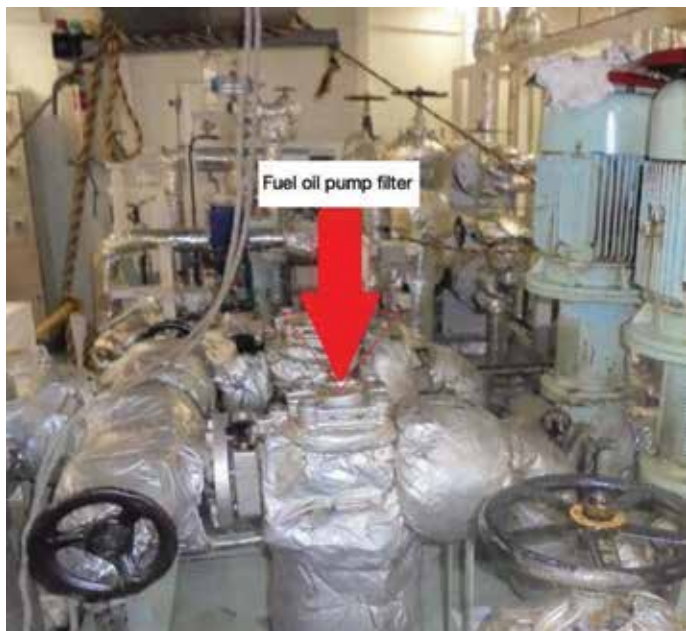
The maintenance work began after lunch. The Second Engineer was dismantling the pump's filter cover, while also acting as the work supervisor. The pump had been isolated by closing the inlet and outlet valves – but the vent cock fitted on the system had not been opened, so the system was still under pressure.

As the pump's filter cover came loose, hot fuel and gases under pressure escaped from the pump. The Second Engineer and three other engine crew who were involved with the work suffered burns on their faces, neck and hands from the hot oil, even though they were wearing PPE (safety hats, gloves and eye protection). After the accident the outlet and inlet valves to the pump were checked and found to be closing efficiently. There were no signs of leakages into the system.

- Checking the boxes of a 'permit to work' form is not going to protect you from the known hazards. Working according to the precautions on the permit will protect you.
- A supervisor who is taking part in the work itself (instead of acting only as a supervisor) is less likely to be able to control the work and assess the risks.
