MARS – Lessons Learned

MARS Report No 384 October 2024

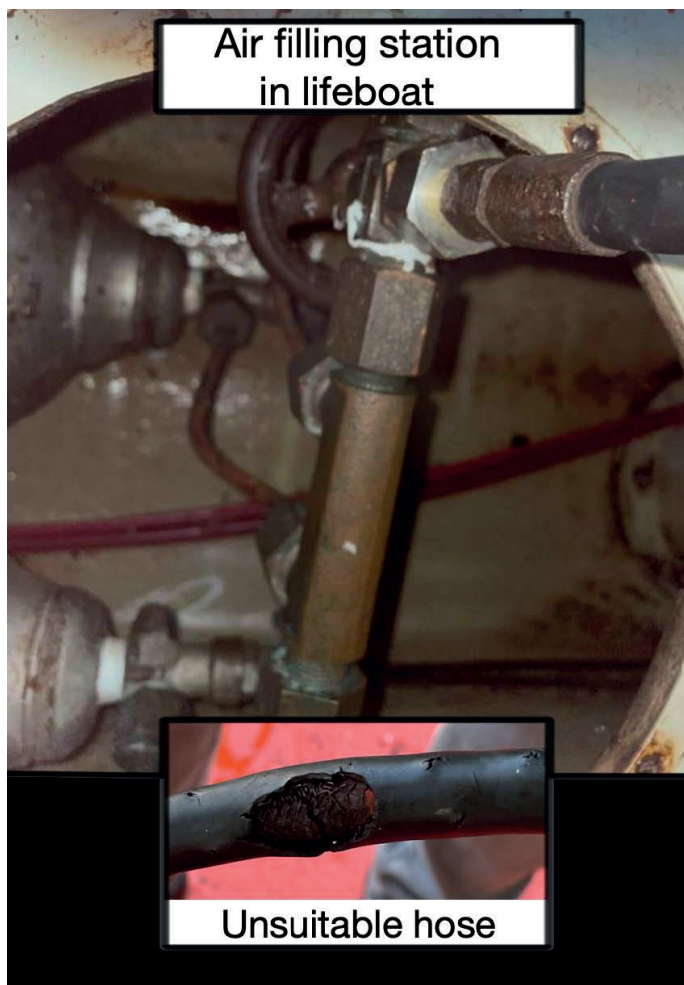
The investigation found, among other things, that some air had re-pressurised the hose. This pressure was enough to initiate a whipping movement when the hose connection released of its own accord, having been nearly unscrewed by the victim.

Due to the lay-out of the air supply system, the person manipulating the air cylinder valves is in a vulnerable position in close proximity to the pressurised air hose. Although the filling hose was found to be in unsatisfactory condition, this was not a contributing factor to the accident. It should have been checked, discarded and replaced with an adequate hose by the crew members prior to commencing the job.

- Gases under high pressure are a potential hazard and risk assessments should adequately capture the risks and present reasonable mitigating practices for workers.
- High pressure components, such as air hoses, should be regularly inspected and unsparingly relegated if found in any way worn.
- Eye protection at all times and for all tasks; ideally it should become as ubiquitous as hardhat use.

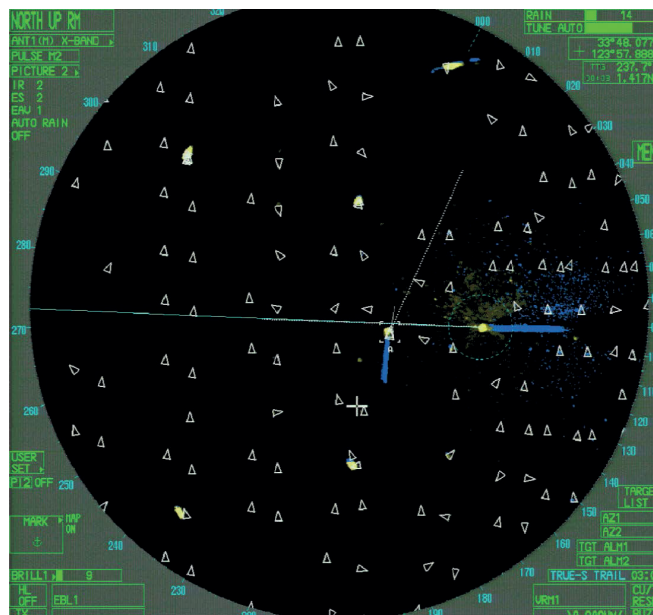
Tanker's radar at 21.33

The investigation found, among other things, that there were no navigational constraints that prevented the tanker from reducing speed or altering course to starboard in ample time. Also, whilst the tanker attempted to attract the attention of the FTV with an Aldis lamp, no use was made of suitable sound signals until five seconds before the collision, when the tanker sounded two short blasts.

- Passage plans should, to the extent possible, be adjusted to avoid well known highly congested fishing grounds.
- It is good practice to reduce speed when in highly congested waters.
- Trying to attract the attention of another vessel? Rule 34(d) is clear. When vessels in sight of one another fail to understand the intentions or actions of the other, or if one vessel is in doubt whether sufficient action is being taken by the other to avoid collision, the vessel in doubt shall immediately show such doubt by giving at least five short rapid blasts on the ships whistle.

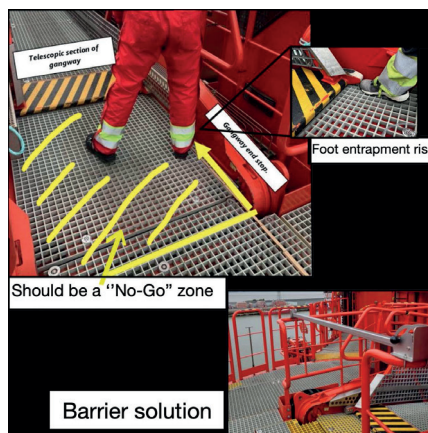
The investigation found, among other things, that the final section of the travel path (soft stop) for the gangway frame was not guarded. Additionally, the gangway operator's training had reinforced the practice of standing on the Telescope Access Bridge platform or in the operator shelter during gangway connection attempts, thus normalising the operators to this practice.

- Guarding was installed along the exposed soft stop of the gangway to ensure a person cannot place their feet in the path of the retracting gangway frame.
- A physical barrier was installed at the base of the telescopic gangway section which prevents the operator from encountering the gangway when it is fully retracted.
- Gangway operator training program was updated with specific focus on entrapment and shearing potential areas on the gangway.
- Develop a set of sea state/vessel movement limits for gangway connections that the gangway operators can use as guidance to make an informed decision on when to stop the job independent of the vessel's station keeping abilities.
