MARS – Lessons Learned

MARS Report No 381 July 2024

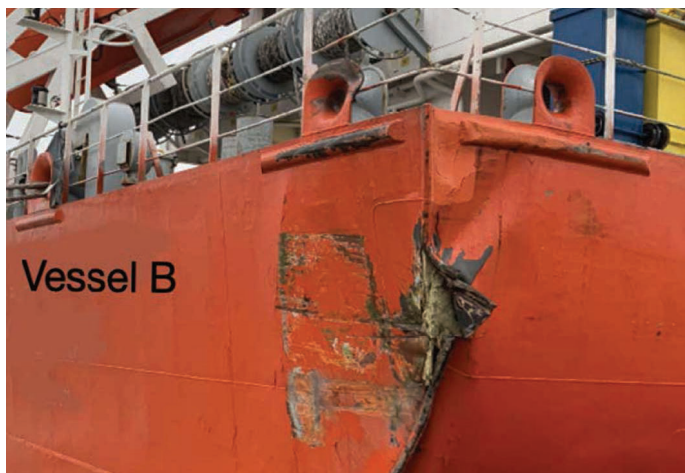
Over the next 20 minutes, vessel A's OOW continued to undertake other duties on the bridge and was not monitoring nearby traffic. As vessel A approached the drifting vessel B on a virtual collision course a crew member who had been working on deck ran to the bridge and alerted the OOW to the developing situation. Still making a speed of 12 knots, the OOW immediately used the autopilot to initiate a turn to starboard before switching to hand steering to increase the rudder angle. However, the turn was not sufficient to avoid collision 10 seconds later. Vessel A's port side struck vessel B's starboard quarter, resulting in hull damage to both vessels above the waterline.

The preliminary assessment found, among other things, that the ECDIS unit on both vessels was set to silent mode, with all audible alarms deactivated while underway. Also, although vessel B was visible on both of vessel A's radars, the target had not been acquired on the ARPA.

- An OOW should actively navigate the vessel and not undertake any other tasks, ever!
- Activated alarms are an asset when at sea – use them.
- If your vessel's navigational situation changes, set the appropriate instruments and signals to reflect this change in status.

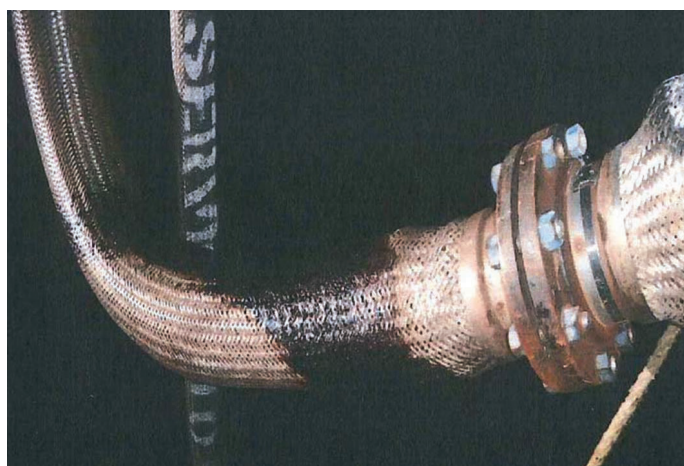
The bunkering station reported normal operations and no leaks so the rate was gradually increased to 180 tonnes/hr. Soon after the rate increase, a minor leak was observed in the hose and the bunkering was stopped. A small quantity of oil had spread on deck and was cleaned. No oil was seen to be released into the sea.

The bunker hose had apparently been tested under pressure four months earlier but was now clearly less than adequate for the job.

- Visual inspection of a bunker hose before use is necessary but cannot guarantee the integrity of the hose under full operating pressure.
- Vigilance at the bunkering station is a primary defence against pollution. When bunkering in darkness, ensure the hose is well lit and visible along its entire length.

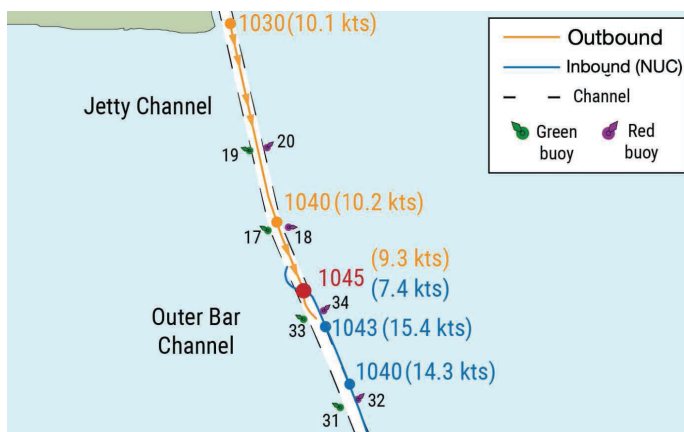
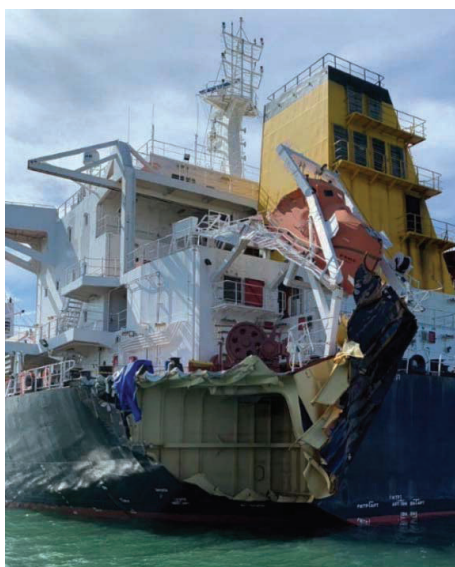
Two minutes after having lost main propulsion and with the NUC vessel still moving at a speed of 7.4 knots and the outbound vessel at 9.3 knots, the bow of the NUC vessel struck the port quarter of the outbound, peeling back about 12 metres of that vessel’s hull plating forward of the transom and wrapping it around the stern.

The official investigation found that the automatic shutdown of main engine on the inbound vessel was likely due to a false alarm. The investigation posited that the oil mist detector had sensed water vapour resulting from the engine maintenance and incorrectly identified it as oil mist. This had falsely triggered the alarm and ensured the automatic shutdown.

- Cooling water can be introduced into engine lube oil systems during maintenance. Ambient air conditions, such as high humidity or extreme cold temperatures, can also increase the water content within engine lube oil sumps. An elevated quantity of water in lube oil systems can trigger false alarms in engine crankcase oil mist detectors (and lead to an engine shutdown).
- After an engine’s crankcase is opened and exposed to cold or humid conditions during maintenance and repair, it is good practice for engine crews to inspect and test the lubricating oil system for water intrusion and ensure lube oil purifying equipment is functioning properly to remove any water or other contamination in the lube oil.

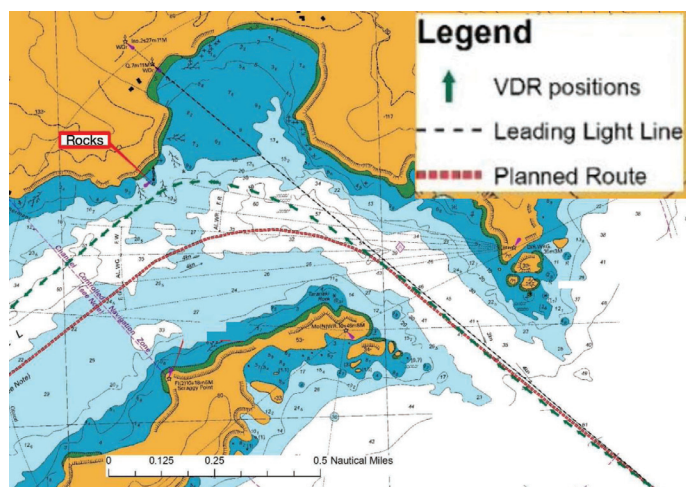
ship was not turning to port as expected, so he ordered five degrees of port rudder followed by 10 degrees in quick succession. The ship was now to the right of the intended track and the cross-track distance from the intended track was increasing rapidly to starboard.

The staff captain noticed the predictor on the ECDIS/Radar display had the ship passing over the land ahead and to starboard. He suggested to the Master that they increase the rate of turn. The Master reassured the staff captain that the cross currents were strong and would bring the ship back to the middle of the channel, reiterating what the pilot had explained during the pilot/Master information exchange.

Soon, an off-track alarm visually flashed on the ECDIS, although audible alarms had been muted before entering the restricted waterway. The ship had departed the predefined safety corridor either side of the planned track, but this information was not brought to the attention of the Master or pilot. Yet, by now they both realised that the ship was proceeding dangerously close to the rocks on the starboard side. Twenty degrees of port rudder was ordered, immediately followed by maximum port rudder. The ship responded with a rapid turn to port. When the ship was approaching the closest point to the rocks on the starboard side, the Master ordered maximum helm to starboard in an attempt to arrest the rapid port turn and prevent the stern from striking the rocks. The ship's bilge keel and the starboard propeller nonetheless made contact as they passed the rocks. The ship was then navigated back to the centre of the channel and continued on its passage to port without further incident.

- The concept of allowing a ship to depart from an intended track in the belief that other influences, such as tide in this case, would return the ship to that track carries a high risk when manoeuvring large ships in narrow waterways where margins for error are small. There is less risk involved when a ship is kept strictly to the intended track by increasing or decreasing its rate of turn in response to the influences of factors such as tide and wind.

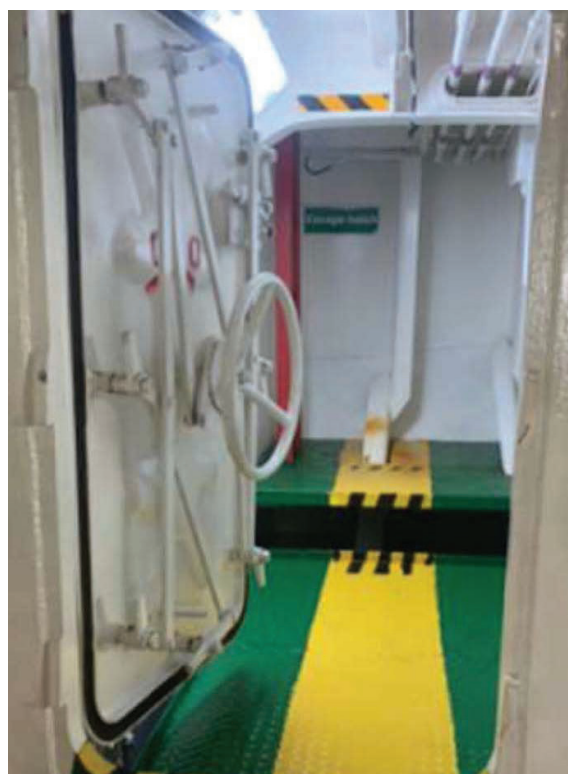
➔ During a safety walkaround on a vessel it was observed that several type C watertight doors (doors that must remain closed at all times and opened only when personnel pass through them) were routinely kept open while underway. It was expressly indicated in the vessel's procedures that these doors must remain closed while at sea.

A review of similar cases on two other fleet vessels found that watertight doors were left open after the regular engine room walk around, as this was a regular activity and there was 'no point to open and close [them] each time.' It was also found that some crew were not aware of the relevant SOLAS and SMS requirements or the importance of keeping type C watertight doors closed at sea in case of emergency.

- Watertight doors are critical elements in preventing the ingress of water from one compartment to another during flooding or accidents. The seaworthiness of the vessel depends on their proper use.
- As with many safety critical elements on a vessel, acceptance of procedures such as keeping type C watertight doors closed by crew is dependent on the safety leadership of senior officers and the Master.
