MARS – Lessons Learned

MARS Report No 377 March 2024

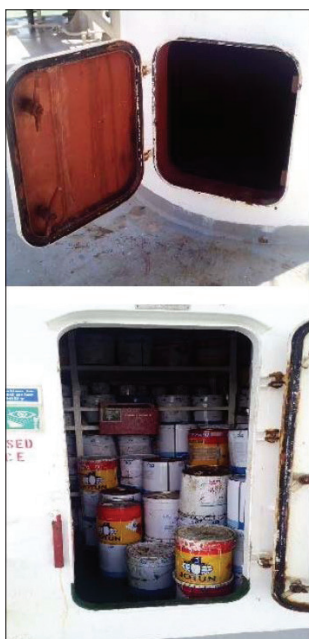
→ A vessel was undergoing a Class inspection. During the inspection, the crew were surprised to find that the lower compartment of a crane pedestal contained many sealed paint cans. The Master was immediately notified and the paint was transferred to the paint locker. The company was also informed and the Designated Person Ashore (DPA) initiated an investigation.

The company investigation found that the paint stored in the crane pedestal was not listed in the vessel inventory, despite a recent update. The paint was transferred to the pedestal during the last dry dock because of a lack of space in the paint locker and ongoing work in the area. The crew who had attended the drydock work did not report this information to the relief crew. The paint in the pedestal was subsequently forgotten due to crew turnover and a deficient inventory listing.

Paint stored in crane pedestal

- The paint locker on a vessel is the ONLY place to store paint and related products. This space is approved for this use and is protected by fixed fire extinguishing equipment.
- Crew handovers are opportunities for information to be lost. Make sure the full state of affairs on your vessel is documented for handover.
- Ship store inventories are important tools for quality vessel management. Keep them true.
