MARS – Lessons Learned

MARS Report No 382 August 2024

MARS 202441

Securing heavy cargo – details matter

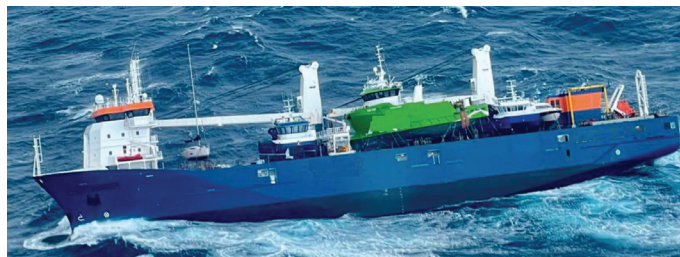
An officer and the cargo superintendent went together to check the cargo hold. They found a large quantity of water and noticed that the three forward stowed azimuth thrusters had been dislodged. One of these three had come loose first and had caused a domino effect, causing the other two to shift as well. The thrusters had punched a hole in the port side anti-heeling tank. This had originally been full, but its contents were now running into the hold.

The report notes that the information about the cargo of azimuth thrusters provided by the freight broker to the operator did not contain any specific instructions for loading, unloading, lashing or any detailed information on lashing points. The chartering department did not request more detailed and specific loading instructions and presumed that the information it had received was sufficient to perform proper lashing of the azimuth thrusters. The discrepancy between the available information and the required information made it difficult to devise an adequate and symmetric lashing system.

Six azimuth thrusters as stowed and lashed

- Even though 'extra lashing' was used, one azimuth thruster nonetheless broke free and caused others to also come adrift. Lashing can only do so much when cargo pieces are extra heavy, as in this case. In hindsight, cargo stoppers should also have been welded at the bases.
- An inland route would have been a safer alternative to sailing across open sea under the predicted weather conditions.
- Heavy cargo items deserve extra attention and detailed lashing plans. For quality assurance, the final lashing state could be observed by a qualified third party.

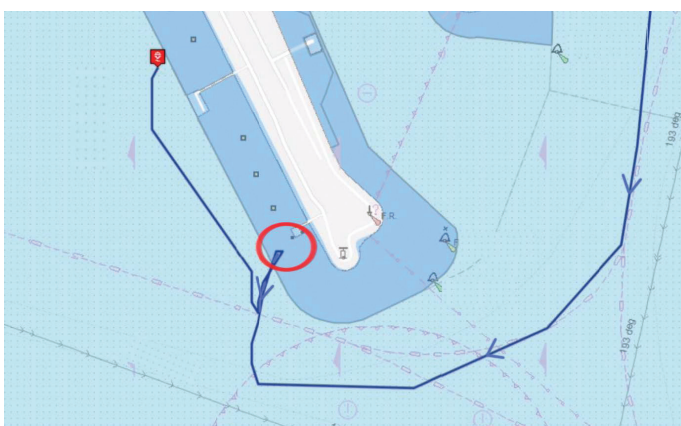
Later, an underwater inspection revealed no damage to the dolphins but the sand around the base of the dolphins was slightly disturbed. The vessel's rudder was found to be about eleven degrees offset to starboard, presumably due to the bottom contact. It was later found that the rudder stock was fractured. Repairs required dry-docking the vessel including installing a new rudder stock. The vessel was off-hire for more than two months.

The incident investigation found that the pilot had misjudged the current. At that time, the pilot reportedly considered that the current was running away from the berth (in a westerly direction), yet the current was actually acting towards it. The investigation also concluded that the pilot was essentially working alone during the docking manoeuvre, thus indicating a Bridge Resource Management (BRM) failure.

Contact with the bottom at red circle

- Even local experts, such as a pilot, can make mistakes. They are human too! Have the bridge team fully engaged with the people doing the manoeuvring and set up agreed distance parameters and speeds when in confined waters.
- Be prepared to challenge the person with the con if the manoeuvre is not going as planned.

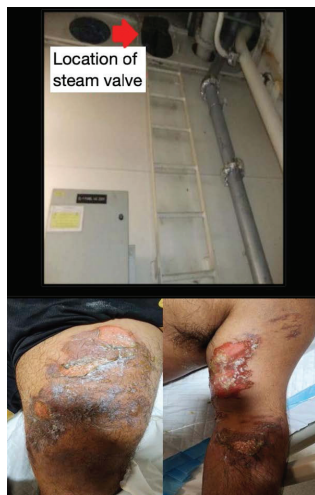
The valve was located in the engine room in an area that required the crew to climb up and into a restricted space. When the crew was in position he began opening the valve, and was suddenly exposed to copious amounts of steam. It was later discovered that the valve gasket had failed, probably due to 'water hammer' effect.

The company investigation found that the instructions on how to accomplish line draining prior to opening the steam valve were inadequate. The crew completed the task as best they remembered based on their own knowledge. Ultimately, formalised instructions are needed to ensure that the steam supply line is free of water before opening the valve to avoid the water hammer effect.

Victim's burns

- New hazards can emerge when modifications are undertaken. In this case it took nine years for the hazard to be revealed.
- New hazards or old (hidden) ones need careful analysis. Then, a procedure should be written and dutifully practised.
