Mariners' Alerting and Reporting Scheme

MARS Report No 352 February 2022

Fishing for lessons learned!

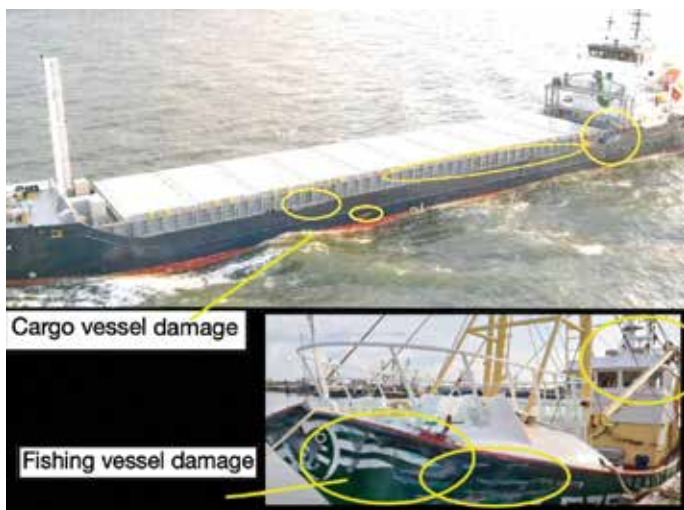
Two of the other fishing boats, A and B, kept a course of approximately 006 degrees. At one point, fishing boat B altered course slowly towards 011 degrees to pass astern of the cargo vessel, but fishing vessel A did not follow this move. Its CPA to the cargo vessel was approximately .05 nm. In the following minutes, the OOW of the cargo vessel noticed that the CPA of fishing boat A had decreased to zero.

By this time another officer had arrived on the bridge of the cargo vessel for the change of watch. Before the handover could be accomplished the OOW on duty realised that fishing vessel A was not taking avoiding action. The OOW sounded the horn to warn fishing vessel A and then put the rudder hard to starboard. About 40 seconds after sounding the horn, the two vessels collided. Fishing vessel A ran into the port side of the cargo vessel amidships and then slid aft. Both vessels sustained structural damage but there were no injuries.

It was discovered during the investigation that the lone watchkeeper on board fishing vessel A did not realise the cargo vessel was there until it was too late. The investigation also found that the 'apparent intentions' of the four fishing vessels contributed to the accident. Some of the fishing vessels did take action to avoid the cargo vessel but in the end, one did not. The OOW on the cargo vessel assumed all the fishing vessel crews had observed his ship, but he was wrong.

- When in doubt and always when a very small CPA is detected, establish early communications with the other vessel and ensure everyone knows what actions are to be taken.
- Sound navigation practices and a good lookout would have avoided this accident as the Master of the fishing boat would have realised there was a stand-on cargo boat on his course with a zero CPA.

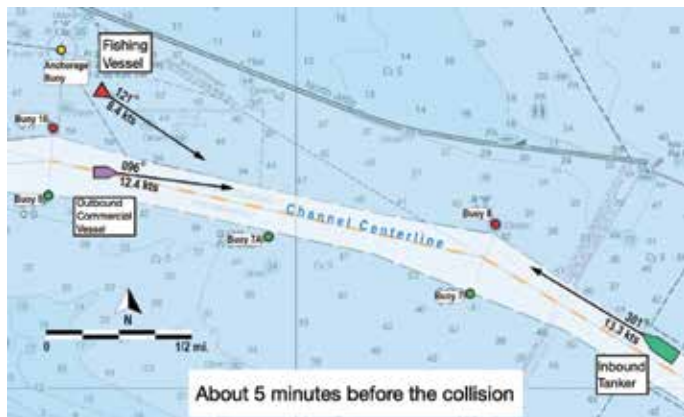
About 90 seconds after the first danger signal and some 10 seconds after a second danger signal, the tanker collided with the fishing vessel, which capsized almost immediately. One crew member from the fishing vessel was rescued from the water alive. Another crew member was recovered from the water and pronounced deceased. The bodies of two other crew members were found within the wreck.

The subsequent official investigation could not determine why the fishing vessel's operator did not slow or take substantial action to avoid transiting into the channel directly in front of the tanker, or what the captain of the fishing vessel was doing in the minutes leading up to the collision. It is possible the captain was away from the conn, was distracted, fell asleep, was unsure of what action to take, or was otherwise unable to respond to the developing situation. The captain's failure to slow his vessel, act on his ARPA's information or respond to the tanker pilot's communications may have been due to a medical event.

- Much as in the previous MARS report, early communication can be an effective measure in averting close quarters situations. The use of VHF radio can help to dispel assumptions and provide operators with the information needed to better assess each vessel's intentions.
