# Mariners' Alerting and Reporting Scheme

MARS Report No 355 May 2022

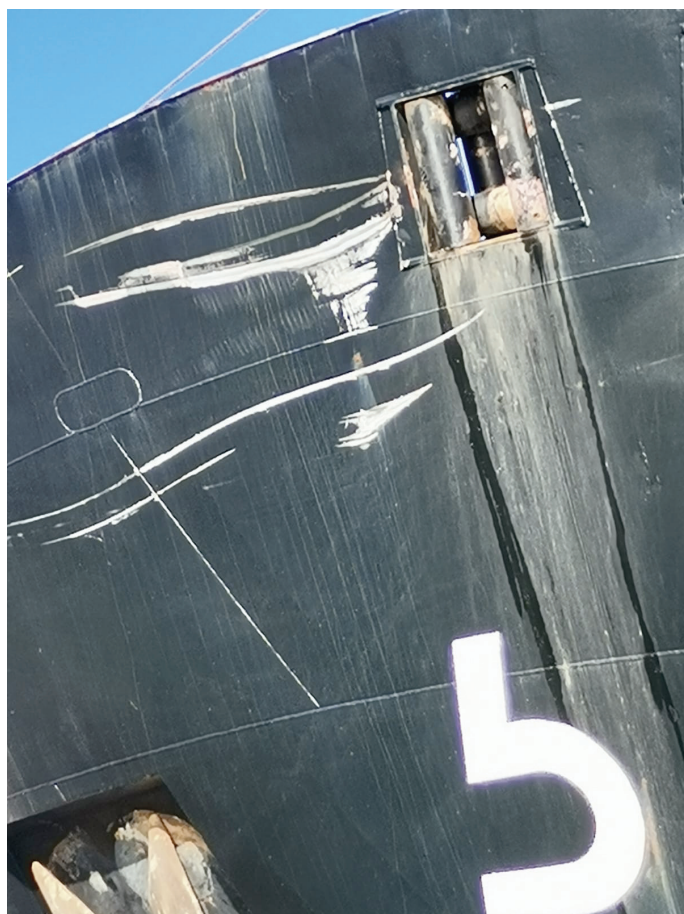
With the oncoming vessel now dragging anchor at about 1.2 knots, the crew at the bow were called back to prevent injuries in the case of collision. The impact was light and caused some scraped paint and a small indentation at the bow just above the starboard anchor.

- Collisions are possible even when both vessels are at anchor. A vigilant anchor watch is always advisable.
- In this case, the vessel that was struck had a vigilant anchor watch, but even that did not save them from a collision. Tight anchorages with vessels less than two cables from each other are fraught with such risks.
- Wind direction shifts in a crowded anchorage can change the risk scenario. What was once a safe situation can change into one of concern.

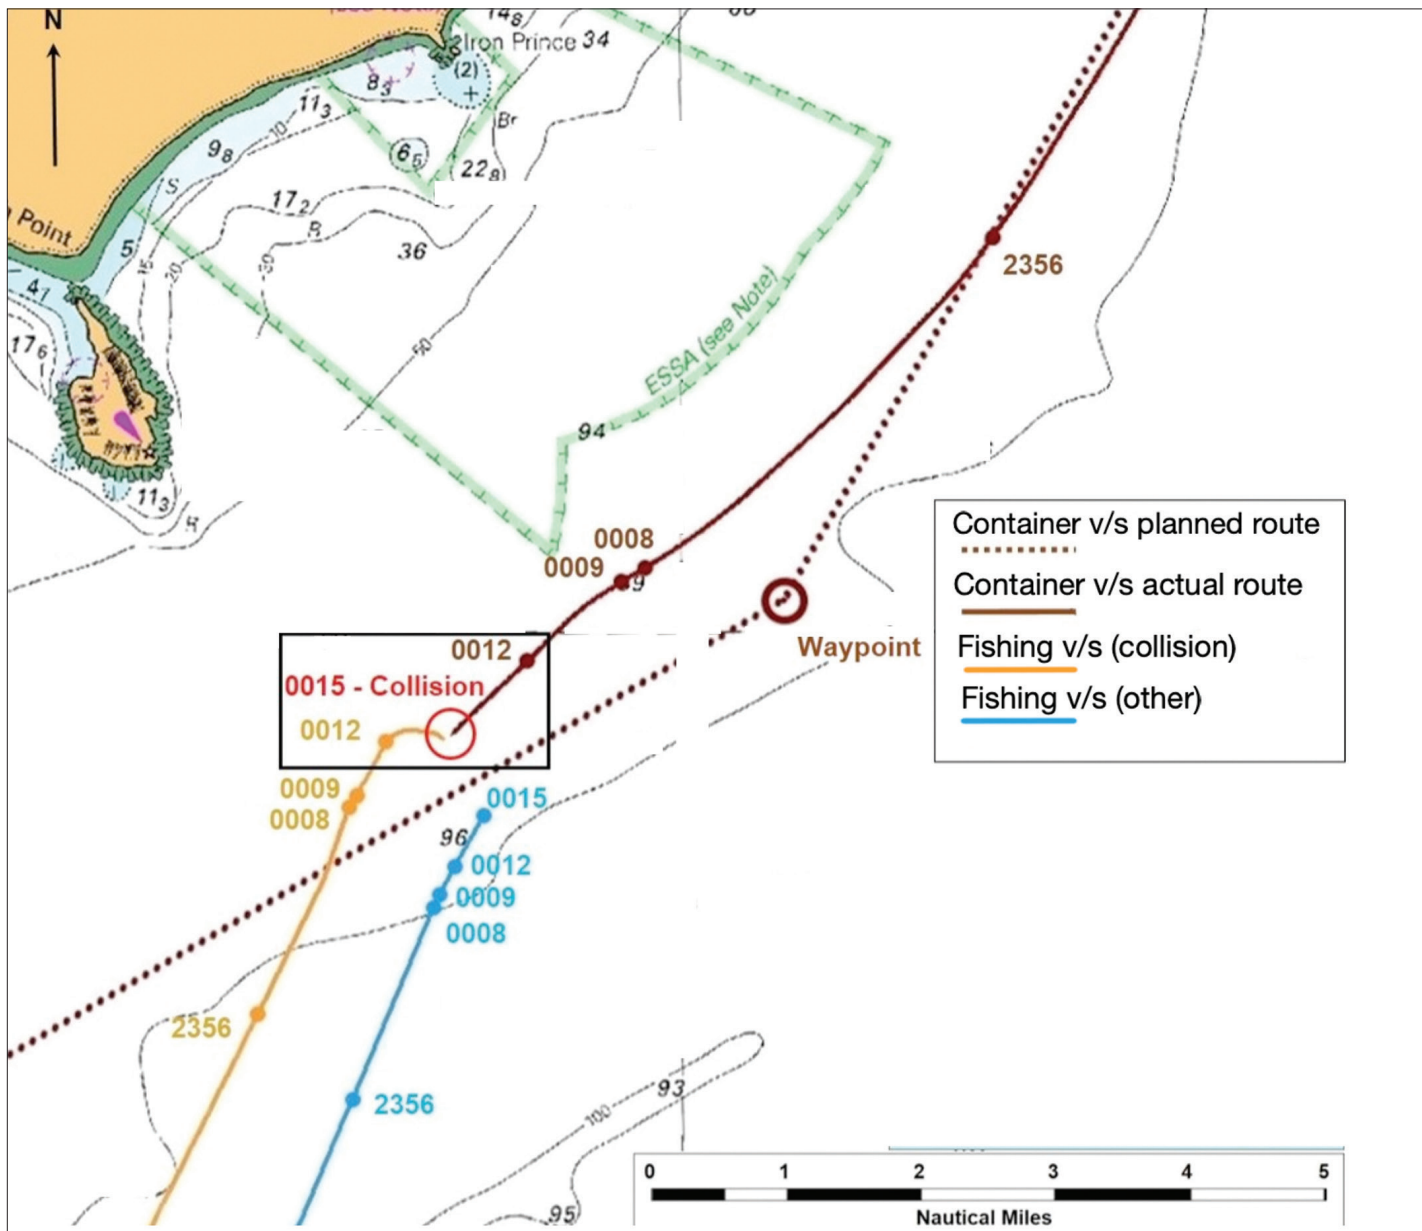
By now, the container vessel was steady on the new course with a heading of 241 degrees with the fishing vessel fine on the ship's port bow. About a minute later, the OOW altered the ship's heading to port with the intention of passing between the two trawlers and increasing the CPA with the fishing vessel under review. Shortly after, the fishing vessel's OOW commenced a rapid turn to starboard at a distance of about 1nm from the container ship. In response, the container vessel's OOW altered the ship's heading to port by three degrees and flashed the ship's Aldis lamp followed by a long blast on the ship's whistle. The OOW then quickly changed the steering over from autopilot to hand steering and placed the wheel hard to port.

Notwithstanding all of these last minute manoeuvres, the two vessels collided, with the trawler’s port bow impacting the container vessel’s starboard side. As the trawler scraped down the container vessel’s side, the skipper stopped the engine and the crew mustered in the wheelhouse. The trawler heeled over sharply to starboard and took on some water before it righted itself, passed the ship’s stern and drifted away to the north-east.

- Early and substantial action is the key to avoiding dangerous situations as above.
- Early and substantial action is not limited to course alterations. Both OOWs were concerned about the developing situation and each chose course alterations as the unique and sole solution. But, because some of these actions were not substantial enough or others too late, they actually contributed to the collision. Had either vessel slowed, the developing situation would have resolved itself.
- When in doubt, slow down.

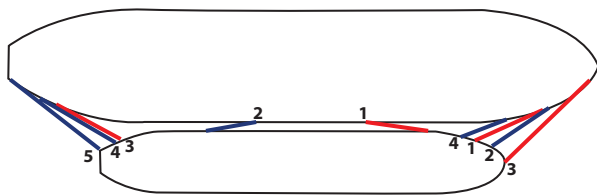
→ Two tankers met at a specified ship-to-ship transfer (STS) area, and were secured together as shown in the diagram. Seas were smooth with a one metre swell and wind was very light (5 knots). Moderate rolling and pitching was noted. Loading commenced but at one point during loading the deck watch reported that a spring line had broken. The crew took immediate action and the failed line was replaced. Transfers continued without further incident.

The investigation found that excessive movement of the vessels in combination with a less than adequate arrangement of protective sleeves caused chafing damage on the mooring lines.

- If wire ropes are available for such mooring arrangements they would be preferable to fibre ropes.
- A thorough mooring analysis and compatibility check should be performed before every STS operation.

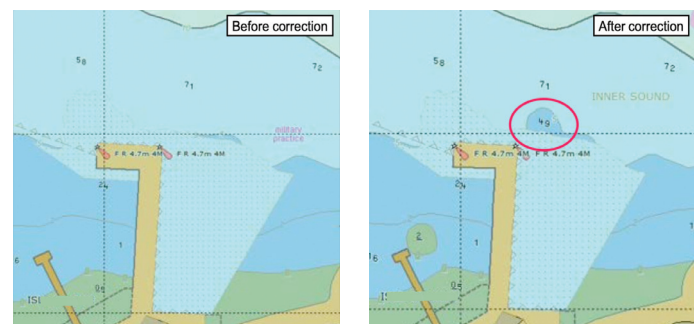
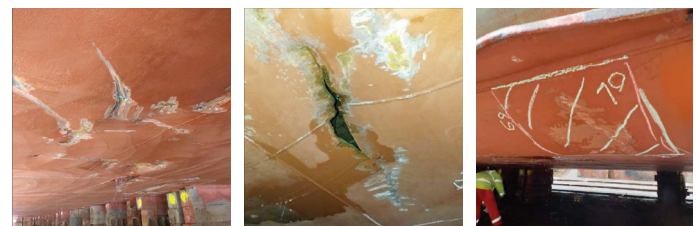
Vessel damage

In the final approach, the OOW advised the Master of a 4.9 metre charted depth just north of the pier. Since the state of the tide was low at 1.1 metre and the vessel was drawing 6.2 metres aft, this meant they would touch bottom if they passed over this charted depth. The Master responded that the echo sounder was reading 7.0 metres of water so he was content to proceed with the berthing. As the vessel approached, now 50 metres north of the pier, there was a sudden shudder throughout the ship. The bow swung to the south and the vessel came

No.5 main ballast tank was experiencing an ingress of water, so the ballast pumps were started to control the flooding.

As it transpired, neither the Master nor the officer had checked the update status of the ENC as part of the planning process. They were unaware that the 4.9m obstruction was a recent correction dated only eight days before the grounding. It was, in the end, more recent and accurate than the agent's pre-arrival information.

- The safest passage plan is one which relies on the most accurate and recent navigation data. Make sure to check yours.
- Entering a new port (for the bridge team) with known strong tidal currents, without pilotage and with critical under keel clearance is a scenario that calls for extra care. Even discounting the fact that the Master believed the 4.9m depth was outdated, entering at high tide slack water would be a better choice than low tide slack water.
