MARS – Lessons Learned

MARS Report No 372 October 2023

MARS 202345

Scrap metal fire hazard

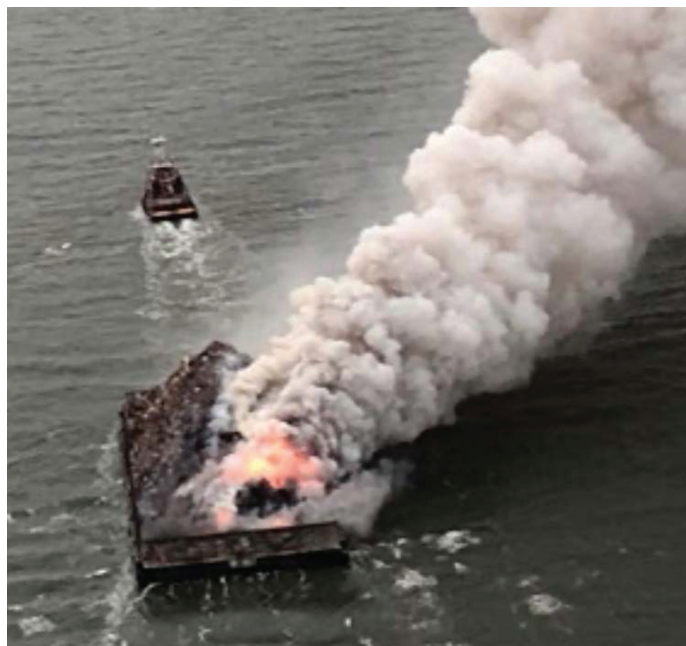
Early one morning a crew member on watch saw smoke and a red glow emanating from the pile of scrap metal on the barge being towed 200m astern. Soon, flames were seen coming from the same area of the barge. The alarm was raised. The fire on the barge was quickly getting larger, and the tow wire was shorted to about 100m to better control the barge.

Soon, Coast Guard and local authorities arrived on scene and began fighting the fire. At this point, the fire on the barge had grown exponentially. The barge was towed into shallower water and beached. Firefighting efforts continued for the next 24 hours before the fire was finally extinguished. No pollution or injuries were reported. Damage to the barge was extensive and estimated at \$7 million.

The NTSB determined that the probable cause of the fire was the ignition of a combustible material by an undetermined source, such as sparking from shifting metallic cargo, self-heating of metallic or nonmetallic cargo, improperly prepared vehicles and appliances, or damaged lithium-ion batteries.

- Scrap metal seems innocuous and is listed as noncombustible in the IMSBC Code, but is nonetheless a fire risk. Another MARS report of this type can be found at 202243 and below, at 202346.
 - Scrap metal fires tend to be hard to extinguish and burn hot and long, often causing major damage. See MARS report below.
- Risk reduction measures for this type of cargo could include:
- Checking the temperature of the cargo regularly to ensure the load is not self-heating. If the temperature is higher than 55°C, the cargo should not be loaded. If, during the voyage, the temperature rises to 80°C, this is a potential fire risk and the vessel should immediately proceed to the nearest port.
 - Appointing a qualified cargo surveying company to assist the vessel's Master before and during loading.

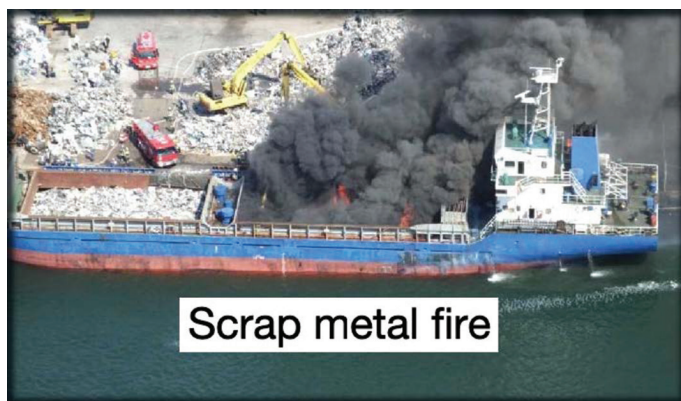
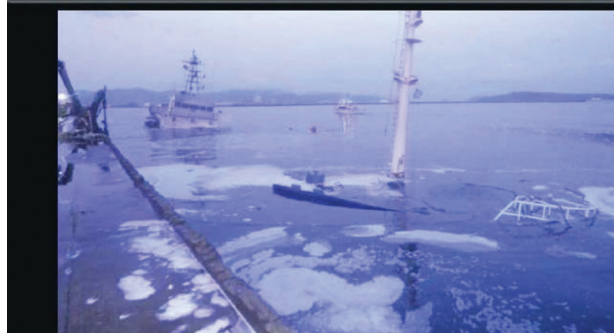
The shore fire department was called while crew prepared fire hoses. Soon, the loader operator – who was still in the hold – saw flames in the scrap heap. A few minutes later, crew were able to direct water jets from fire hoses onto the scrap metal heap. The loader operator evacuated the hold, leaving the arm of the loader extended above the hatch coaming. Local shore fire fighters arrived and took control of the fire fighting activities. Not long after, the crew were asked to evacuate the vessel for their safety.

The shore fire fighters decided, based on experience in past firefighting of ship fires, to use a protein foam spray delivered from a large aerial-platform chemical-spray fire truck. As they made preparations for the application of the protein foam spray, the vessel listed to port, and the firefighters on the vessel withdrew. The fire continued to increase in size. About an hour after arriving, the shore fire fighters began spraying the protein foam into the aft cargo hold. This technique did not seem to have the desired effect and the shore firefighters asked the Master for permission to continue to use water. Permission was granted, but some 12 hours later, after the application of copious amounts of water, the vessel sank alongside the berth. The fire was then declared extinguished.

The investigation found, among other things, that the source of the fire was most likely to be a spark created by contact between metal objects, a battery, etc., in the scrap. The source then ignited combustible material mixed in the scrap (eg plastic, rubber, wood chips, paper). It was not possible to determine the exact origin of the fire.

The investigation also found that the Master did not think to use the hold's fixed CO₂ firefighting equipment after the fire was first discovered. In fact, this was a moot point because the loader was left with its arm extended above the hatch coaming. This would have prevented the closing of the hold's hatch, a necessary first step before releasing CO₂.

- As seen in the previous MARS report (202345), scrap metal, while intuitively innocuous and listed as noncombustible in the IMSBC Code, is nonetheless a fire risk.
- Reactions during an emergency are honed with training. Masters and crew should be aware of the most efficient fire fighting methods on their ship and quickly be able to put these into practice.
- Copious and uncontrolled amounts of water poured into a ship will cause a loss of stability and possibly the foundering of the vessel. This will, however, probably succeed in extinguishing any fire on board.

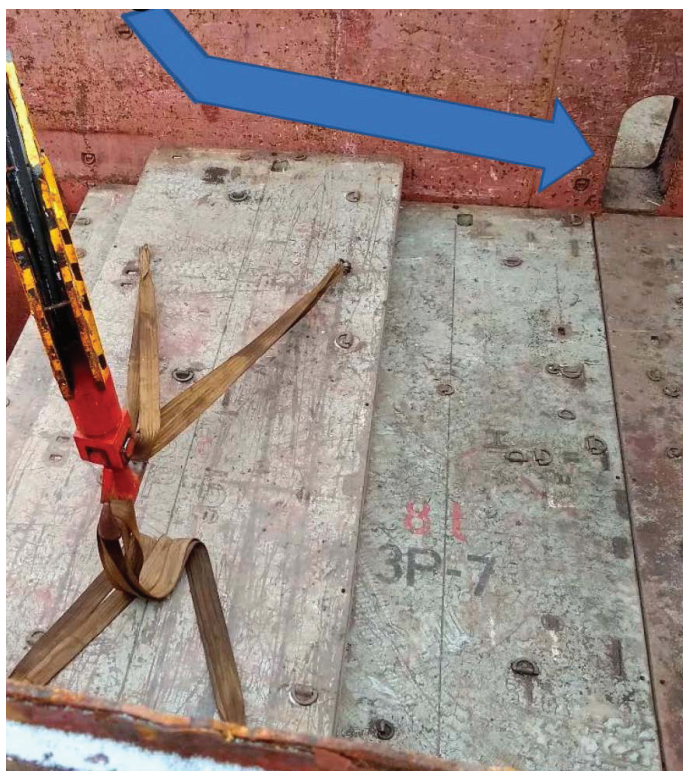
Designated safe area

The two crew were positioned in the forward part of the cargo hold, where they would hook the pontoons on to the crane. A third crew member was assigned to un-hook the pontoons once they were laid down on top of other tween-deck pontoons against the bulkhead in the aft part of the cargo hold. This crew member had to shelter in a safe position aft until the first pontoon was laid down on deck. The dedicated safe position during the manoeuvring was inside a passage between the port and starboard holds.

The lifted pontoon did not make any uncontrolled movement. The pontoon was not swinging or turning. Reportedly, nothing unusual was heard or seen until the signalman saw that the crew member who was supposed to be sheltering aft to unhook was lying on the deck. The signalman raised the alarm with the VHF radio and stopped the operation. The victim was given first aid and a doctor came to the scene but he was declared deceased.

The investigation found, among other things, that because the pontoon itself had blocked a proper and full view of the work area, neither the signalman nor the crane operator had been able to see that the victim had entered the danger zone between the bulkhead and the hoisted pontoon. Although the victim knew to stay in the designated shelter area until the pontoon was safely down, it is possible he attempted to quickly remove some cargo debris as the lift was under way.

- Human nature is such that we want to get the job done – the 'can do' attitude which probably explains the victim not remaining in the designated safe area. The 'can do' attitude can be perilous if we ignore established procedures in the process.
- The victim did not have a VHF radio so he would have been unable to stop the operation, had he seen this was necessary.
