Mariners' Alerting and Reporting Scheme

MARS Report No 360 October 2022

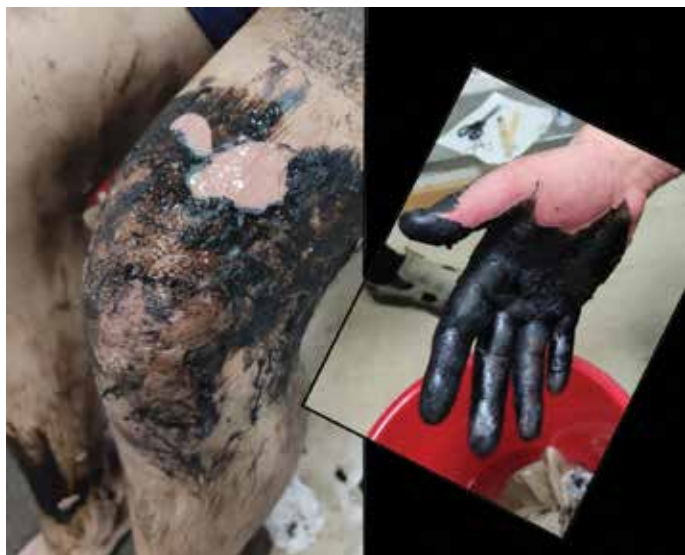
Procedures also specified that two crew should always enter the engine space together. Despite this, the engineer on duty entered the space alone, and did not put on his coveralls and gloves as he entered the engine room – again contrary to procedures. Having transferred to the standby separator and shut the alarming separator, he opened the plug of the inspection hole of the sludge discharge line to verify the condition. The discharge line was completely blocked, so this did not decrease the pressure between the blockage and the bowl opening. Hot (40C) sludge oil gushed out of the inspection hole and covered the engineer's arms and legs.

12% of the victim's skin surface had been covered in sludge, mostly on his arms and legs.

- A long sleeved overall and leather gloves could have greatly reduced the amount of sludge that contacted the victim's skin.
- The regular clogging of the fuel oil separator on board was probably due to the cold flow properties of the particular blend of VLSFO in use. Mitigating action was taken to keep the process running by cleaning the oil separator twice a day, but the source of the problem had not been dealt with. A more detailed analysis of the specific blend of VLSFO, and in particular its cold flow properties, could have solved the separation problems with this blend of fuel.
- Cleaning the separator was not a standard job on board. It was decided to carry this out twice a day to deal with the new batch of fuel, but no further risk assessment or safety measures were implemented to mitigate the risks associated with this job.

- Expect the unexpected - in this case, that the discharge line was completely blocked.
- The discharge line was not equipped with a pressure gauge, since the sludge inside the discharge line is normally not under pressure. It was unusual and unexpected that the sludge was under pressure after switching off the separator.
- This is yet another example where lack of proper PPE was an aggravating factor for the negative consequences.

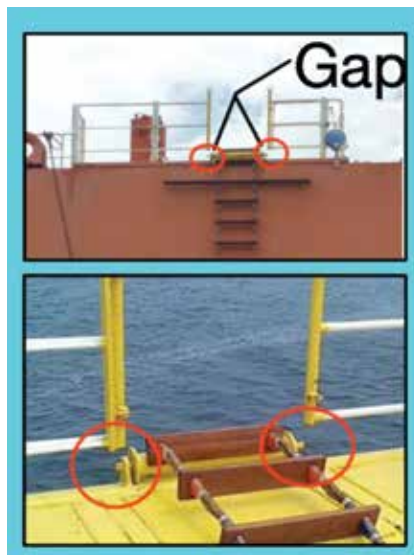
→ The US Coast Guard is investigating a casualty involving a fall from a pilot ladder where the handholds in the gate arrangement aboard the vessel were modified so that the gate arrangement was not rigidly secured to the vessel's structure at the point where the ladder comes

aboard. This left a gap in the handholds where an embarking person might reasonably be expected to reach to pull themselves up.

The gap above the vessel structure appeared to be a modification to allow for the passing of the spreader during deployment and retrieval of the pilot ladder. This made it possible to retrieve the pilot ladder without having to lift the spreader up and over the vessel's railings.

A Safety Alert has been issued, although, at this time we cannot speculate on how this modification contributed to the accident. Readers are reminded that pilot ladder requirements as specified in SOLAS 2004 (Consolidated) and by IMO Resolution A.1045 (27) should be strictly adhered to.

The International Organization for Standardization (ISO) recently published a series of standards aimed at improving pilot ladder safety. These standards supplement existing IMO recommendations and requirements for pilot ladders. Vessel owners and operators, shipboard personnel and system designers are strongly encouraged to review and comply with these standards.
