MARS – Lessons Learned

MARS Report No 387 January 2025

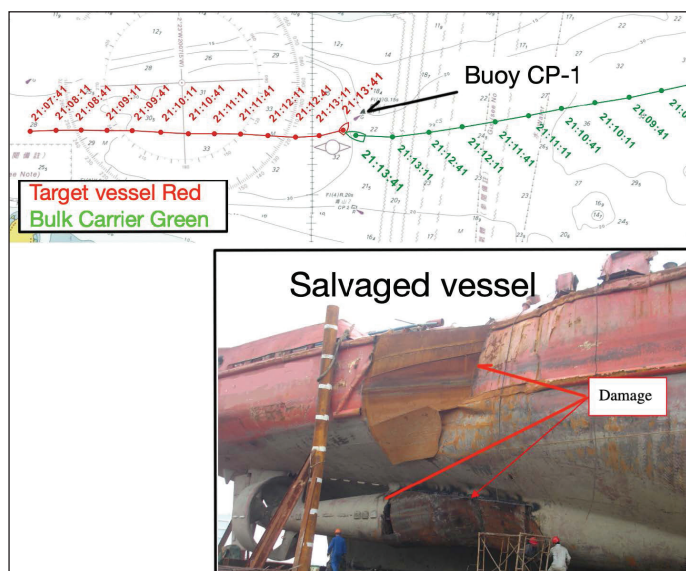
By this time, the target vessel was very fine on the port bow and at a range of about 0.5 nm. Within seconds the target vessel was observed to alter course to port rapidly. The pilot ordered starboard 20 followed by

As the target vessel continued to alter course to port, the co-pilot on the bulk carrier again sounded five short blasts on the whistle. The pilot ordered port 10 to allow the target vessel to pass clear ahead. Despite these actions, the bow of the bulk carrier struck the starboard quarter of the target vessel at about 90°. The collision was heavy and the bulk carrier vibrated violently. The engine was stopped and the crew mustered to go to anchor, as the forepeak was flooding.

- With a closing speed of 23 knots, time is of the essence. The target vessel was detected on radar at only 2.5 nm. This leaves barely 6.5 minutes before collision. Keep a good lookout by all available means.
- The investigation found that 'the pilot expected the target vessel to alter course to starboard'. Yet, for a near head-on meeting, both vessels should be expected to alter to starboard.

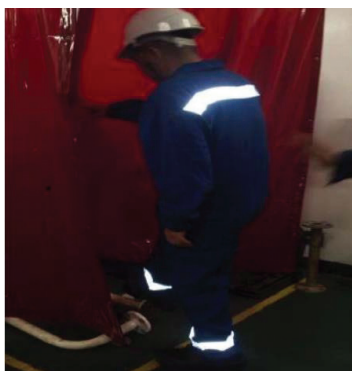
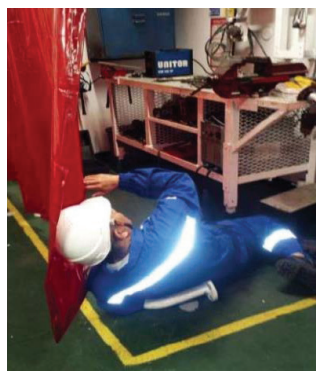
Simulation of the accident

➔ An engineer was conducting a safety round in the engine room workshop welding area while the vessel was underway. Some welding had been done earlier but was not yet finished and the welding curtain was still in place. As he walked, he hit his foot on a loose pipe on the deck that had been hidden by the welding curtain.

The engineer lost his balance and fell on the deck, with the left side of his back hitting the flange of the pipe. He was able to stand back up and immediately informed the chief engineer. The victim was given preliminary first aid and 10 days later sent ashore for an examination. He was diagnosed with bruised ribs and was proactively repatriated five days later.

- Every close call or incident/accident should immediately be reported, as in this case.
- Simple good housekeeping habits can help avoid such tripping accidents.
- Even mundane trips can cause injuries severe enough to lead to repatriation.

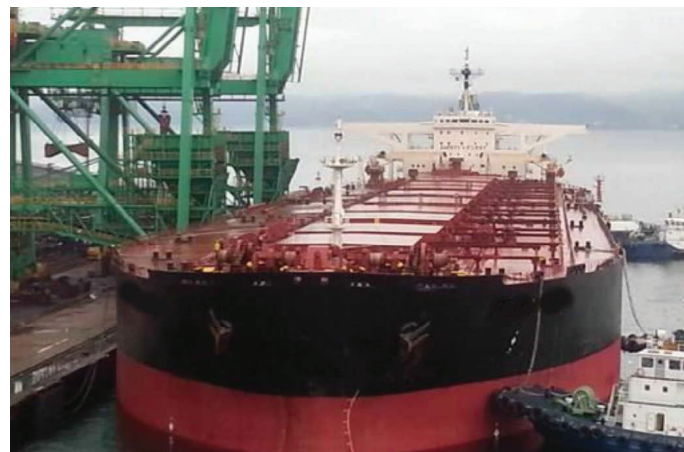
Casualty vessel before sinking

The investigation found, among other things, that the loading conditions of the vessel satisfied the damage stability criteria required by the conventions at the time of the accident. Even if ballast tanks 2 and 3 (P) were both damaged, it seems hard to establish that this would have caused the ship to sink in such a rapid fashion.

- Over more than 24 years of operation, asymmetric loads (hence pressures) would have placed excessive stress on the lower shell plate, gradually causing a loss of hull strength, both structural and fatigue related. This resulted in catastrophic hull failure, causing the large vessel to sink within 5 minutes.
