# MARS – Lessons Learned

MARS Report No 380 June 2024

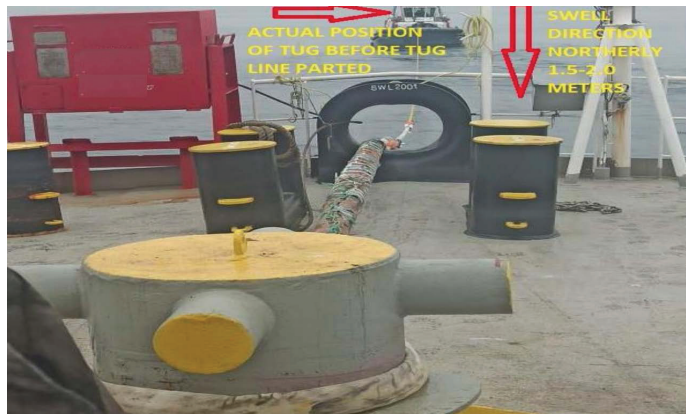
MARS 202429

➔ A tanker had moored to a single point mooring (SPM) buoy ready to start discharging operations. A tug was used aft to apply tension on the vessel and keep it in line with the predominant swell during the discharging operation. Wind and swell were coming from astern and were just within the maximum agreed conditions so discharging operations were started.

Over the next 40 hours of discharging, the tug's line to the tanker broke six times. Each time a break occurred the discharging was halted and another line was installed. Then discharge operations continued. At no time did the tanker's Master question the mooring Master's decision to continue the discharging operation or to stop work and re-evaluate the conditions or the assumptions on which past decisions were made.

- Luckily, no injuries were sustained during these incidents. Hindsight being 20/20, it seems clear in retrospect that after several line failures (3?, 4?) a decision to delay the discharge should have been taken by the vessel's Master or the mooring Master.
- When bad outcomes happen, investigate – ask why! At a minimum, reevaluate the conditions of work.

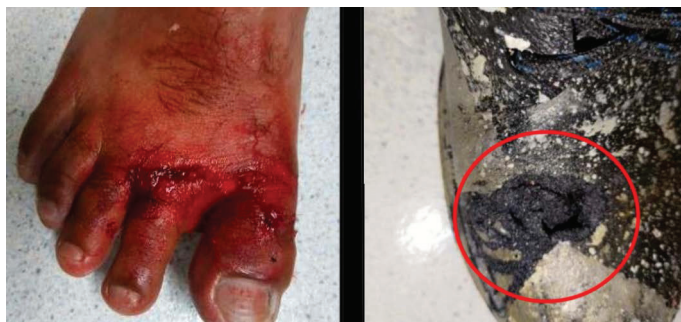
MARS 202430

After a full morning of this work, the crew returned to the job after lunch. At one point, the water jet was inadvertently turned towards the foot of the crew member handling the nozzle. The water jet penetrated his safety shoe just above the steel protection (photo, right) causing an injury to the foot. The victim was assisted to the ship's hospital where first aid was administered.

No fracture was found by X-ray and no infection or skin necrosis was observed. He returned to full duties shortly after.

- A pressure washer is like a loaded gun – see also earlier MARS reports (201921 and 202337), which also highlight injuries due to this equipment. The water forces generated can cause severe injury when in contact with a person's body.
- If a pressure washer is on, always hold the lance with both hands to have full control. Never point the lance at yourself or others.
- Proper PPE will help reduce the severity of an injury but is not infallible.

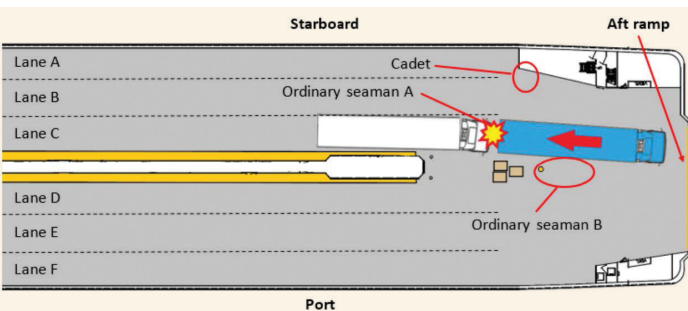
MARS 202431

One semi-trailer truck had already been parked in lane C and another one was being directed to reverse in the same lane by crew member B, parking in front of the first truck. As this was happening, crew member A stepped in front of the first parked truck to retrieve an electrical cable. He then realised the second truck was reversing towards him, and tried to escape his precarious position but was trapped.

Among other things, the investigation found that crew member A had not conducted loading towards the aft ramp in lane C before. Neither of the crew members on duty had previously been responsible for reversing vehicles. As it was, they were tasked with duties with which they did not have previous experience but were expected to perform safely nonetheless.

- While wearing high visibility PPE is certainly a needed precaution for crew loading a ferry, this precaution does not solve everything. Good judgement and common sense are also needed.
- Good communication is a key component of safety. In this case the crew member directing the truck was not in contact with the victim.
- The victim's actions are an example of single-minded attention to one task; he wanted to retrieve the electrical cable. But, without first examining his environment, he walked into a dangerous situation. Always keep your situational awareness sharp!
- A preferred practice is to mix an experienced crew with a less experienced crew member in order to reduce the chances of inexperience causing a negative outcome.

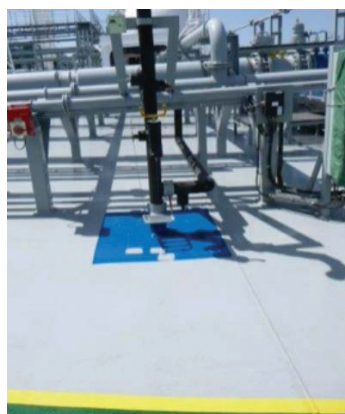
Before

➔ On a tanker during a Safety Observation Round it was found that there was no anti-slip paint applied to give safe access to the emergency shower station. Wet decks are notoriously slippery. Also, if an emergency shower station is needed, it is probably an emergency and victims will probably not be paying attention to the condition of the deck.

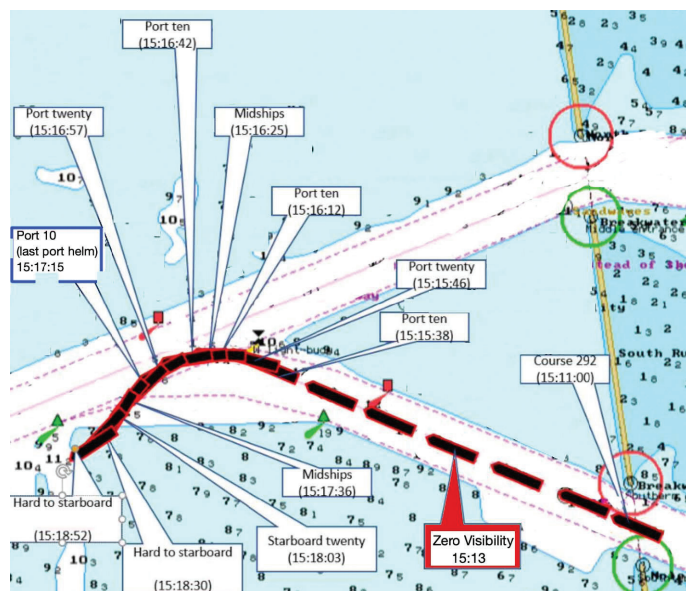
**MARS 202433**

➔ A loaded cargo vessel was outbound under pilotage in daylight and moderate visibility. A tug was in attendance but was released once the vessel was past the port breakwaters. About seven minutes after the tug departed the vessel, visibility unexpectedly reduced to about 200m. The vessel was at a speed of six knots, and over the next two minutes the pilot gave helm orders to make a 44 degree port turn out to sea (see diagram).

The vessel turned further to port than desired. Once the pilot realised this, he gave starboard helm orders, but it was too late. The vessel grounded outside the buoyed channel about four minutes after the first port helm order was given. Attempts to use ship's power to return to the channel were fruitless and salvage tugs were needed.

The investigation found, among other things, that the vessel lacked a complete voyage plan to exit the harbour (ie courses, safety distances, clearing bearings, rate of turn etc.) and that the pilot was navigating primarily by visual means. When the visibility unexpectedly reduced, the bridge team were at a disadvantage. No one on the bridge was in control of the progress of the 44 degree port turn by electronic means such as ECDIS or radar.

- A shared plan is a safer plan. In this case, the plan was in the pilot's head, much as we saw in MARS 202153.
- Even with a pilot on board a Master should ensure courses are put on the chart or ECDIS and OOWs are closely following the progress of the vessel.
- Visual navigation in fog is a recipe for an accident.
- When in doubt, slow down if possible. In this case the vessel was

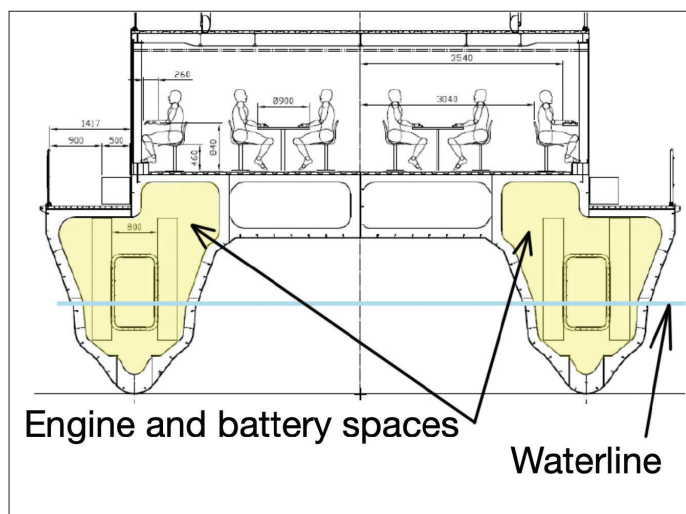
Fire damage to starboard battery room

Technical examinations showed that the fire started in a battery stack module. It is highly probable that seawater ingress through the ventilation outlet had leaked through the ventilation fan and down onto the batteries. This caused a short-circuit and electric arcs, which were considered to be the source of the fire.

The investigation also showed that the battery system had a low ingress protection (IP) rating, so that when seawater entered the battery modules and high-voltage components there were severe consequences. A higher IP rating (and therefore a higher degree of protection) would have reduced the consequences of seawater ingress to the battery room. It would appear that the regulations do not sufficiently address the need for ingress protection of battery systems.

Important information about flooding points from the ventilation system to the battery room was missing from the freeboard plan. This meant that the regulatory personnel responsible for approving the freeboard plan were unaware of the position of the ventilation outlet and the risk that it posed. After the accident, the vessel owners have made several changes to the ventilation system.
