# MARS – Lessons Learned

MARS Report No 385 November 2024

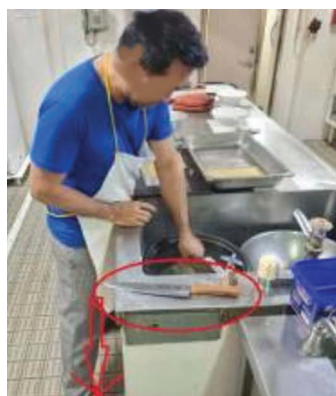
Before

→ A vessel was underway and experiencing severe rolling and pitching due to a heavy, long swell. In the galley, personnel were preparing the next meal. While passing near the galley, another crew member observed that the chief cook had placed his chef's knife on the edge of the prep table, directly above his right foot.

The crew member intervened and reminded the chief cook that, given the vessel's movement, this could lead to an unfortunate accident. The chief cook agreed and placed the knife on the magnetic holder.

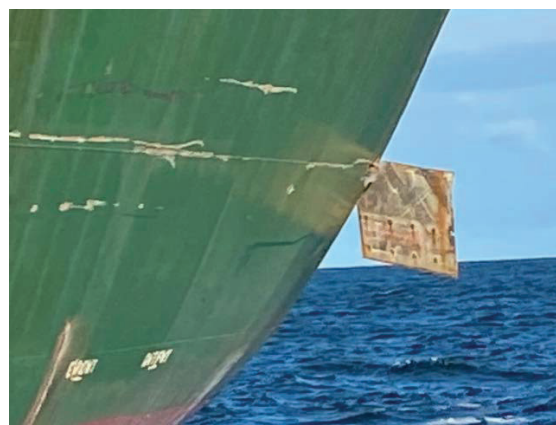
→ A loaded vessel was departing a berth in very confined waters without tug assistance. Winds were NNE, almost parallel with the berth, at about 25-30 knots. Two pilots were on board but according to the company report, there were gaps in the Master/Pilot Exchange. The bridge team did not have a shared understanding of the vessel's handling characteristics and the planned manoeuvre was not held as a shared mental model.

As the vessel moved away from the berth, the stern came into heavy contact with the berth. A metal plate that had been fixed to the cement wall became lodged in the vessel's side shell. The unberthing manoeuvre continued, and the vessel left the port but went to anchorage for a damage assessment. It was found that contact with the plate had caused a hull puncture. The hole was estimated to be 250 mm high and 120 mm wide.

- In challenging weather conditions, without tugs and in confined waters, a re-evaluation may be needed. Can the departure be postponed? In reality, any departure can be postponed if deemed too dangerous.
- A shared mental model of a manoeuvre held by the entire bridge team is usually a safer plan than a plan held by one individual.

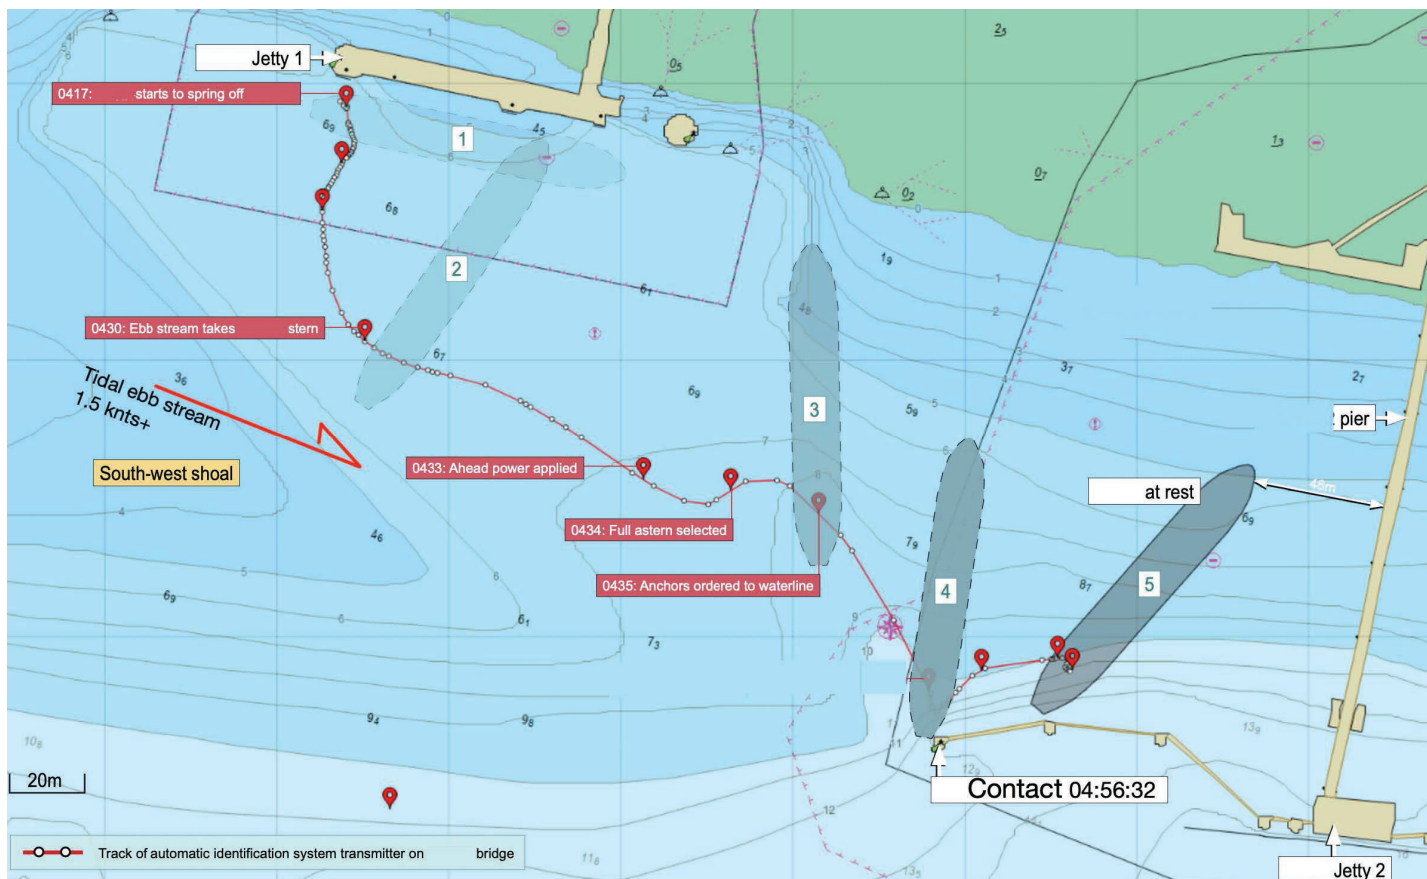
The pilot again ordered 'Hard starboard, kick ahead, kick ahead'. Twelve seconds later, the tanker's starboard aft quarter collided with the westernmost dolphin of jetty 2. With the engine now full ahead and the wheel hard to starboard, the vessel scraped along the dolphin. Soon, both anchors were down and the engine was set to stop. The vessel's stern cleared the westernmost dolphin, but as the bows pushed into the soft mud of the riverbank the stern hit the walkway on jetty 2, dislodging a section of the jetty. The vessel was now stuck, the vessel's bows partly held by the anchors lying to port and by the mud of the riverbank. The vessel's bows were approximately 48m away from the pier of jetty 2 and the stern was resting on the jetty. Some time later, the tanker was re-berthed with the assistance of two tugs.

- The pilot was probably fatigued when boarding the tanker and during the departure manoeuvre. Judgement and reaction time are adversely affected by fatigue.
- The pilot had not visited jetty 1 for more than four years so he had not encountered the new extension to jetty 2. He was therefore unfamiliar with how much this new berth extension constrained the available navigable water, especially for a departure when docked in the easterly direction with a strong ebb tide.
- The pilot was not informed of the mandatory tug requirement for such ebb tide departures from jetty 1. He was not alone in this lack of local knowledge; the port controller and the VTS officer on duty at the time of the accident were also unaware of the requirement. This was a recently implanted risk mitigation measure that had been poorly disseminated to persons of interest.

- In this instance we can observe the near total collapse of Bridge Resource Management (BRM). On the one hand, the pilot was not properly supported in the manoeuvre by the bridge team. No one was assigned specific tasks. On the other hand, the Master, notwithstanding his misgivings about not employing a tug, acquiesced to the pilot's misinformed judgement, although the pilot's abilities were undermined by fatigue. Lesson for Masters – trust your experience, and delay departure if you have doubts.
- Incredibly, neither the pilot, the port duty officer, the VTS officer, nor the agent knew that an east-facing vessel in an ebb tide was required to have tug assistance for departure. How could we expect the Master to know? However, given the very restricted waters and strong ebb tide, normal seaman-like precautions would have dictated the presence of a tug.
