# MARS – Lessons Learned

MARS Report No 378 April 2024

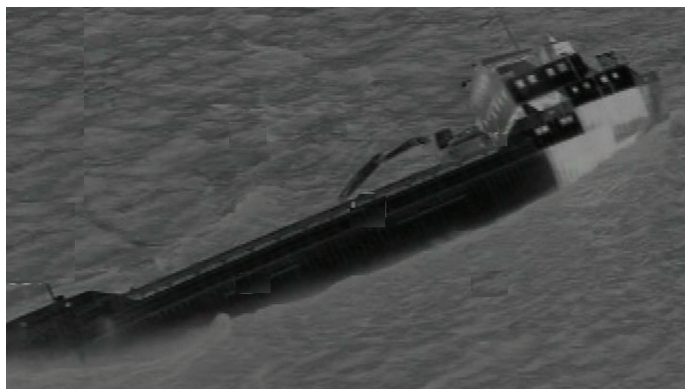
The official investigation found it likely that there was moisture in part of the stockpiled soil that was loaded. The ship's movements caused the cargo to undergo a transformation and initiated the sequence of listing events which culminated in the foundering of the vessel. As it happened, no samples were taken of the cargo, and the cargo was not tested for its transportable moisture limit (TML). The IMSBC Code does not list soil as a Category A cargo, so testing was not a requirement. Neither the shipper nor the vessel's crew were familiar with the properties of the cargo.

Vessel just before foundering

- If, during loading, there is reason to suspect that the moisture content is in excess of the TML, stop loading the cargo, inform the owners and seek further advice from your P&I Club.

- If laboratory tests have not been conducted on the cargo, crew can carry out a complementary test on board, known as the 'Can Test' in order to determine, approximately, whether the cargo is at risk of flowing. For example, see the following publication:

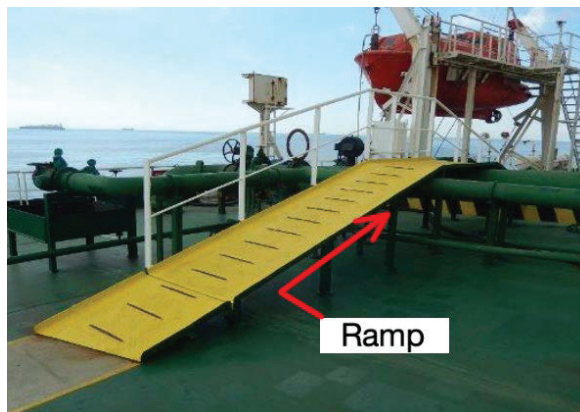
While crossing the deck ramp, he slipped on the damp surface, lost his balance and fell to the deck from a height of around one metre. The victim complained of a sore left elbow, which had taken the brunt of the fall, and was given first aid. Later that day he was sent ashore for medical attention.

The company investigation found that he was not holding the handrail of the ramp while crossing. Also, his choice of routes, using the shorter port side option instead of the starboard 'safe way to the bow', increased the chances of an accident or incident.

- Shortcuts are rarely the safest option, but they are often taken, especially for mundane tasks, as we feel we are in control and that nothing could happen. But it does.
- Stairs and ramps require three points of contact for a safe passage.

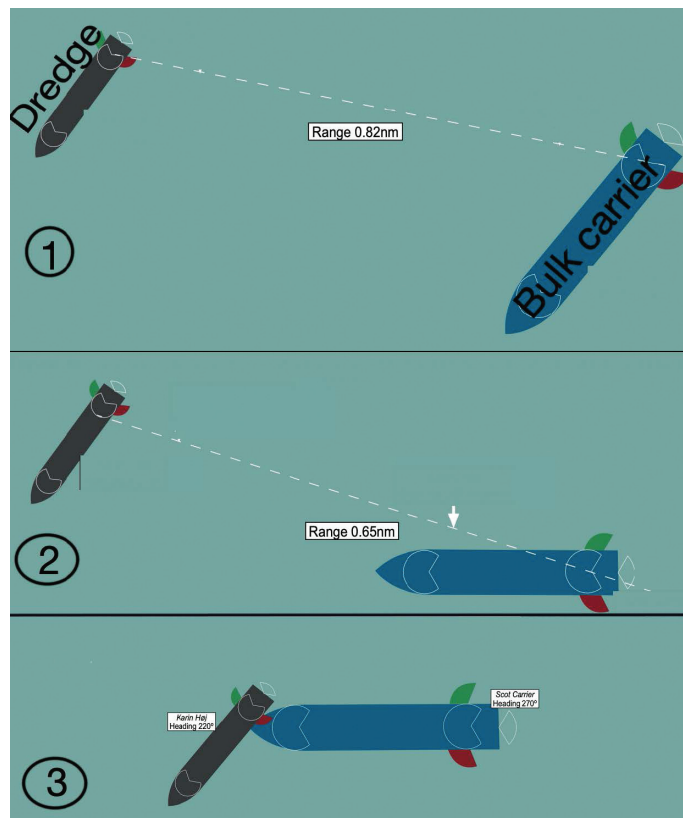
Shortly afterwards, he switched on the searchlight to show a chat user the ship's deck and cargo on the hatches forward. He then continued to engage with several individuals on the chat site. At 03:03, the bulk carrier's AIS registered the dredger as a dangerous target 2.2 nm ahead on the starboard bow, with a closest point of approach (CPA) of 0.88nm and a time to CPA of nearly 20 minutes. About 18 minutes later, with the vessel close to a course alteration waypoint, he told the chat user that he needed to alter course and adjusted the autopilot to 270 degrees. The dredger was now bearing 289 degrees at 0.82nm range (see picture 1).

Notwithstanding these last minute attempts, the bulk carrier collided with the port side of the dredger at a relative speed of 8.7kts (picture 3). The bulk carrier's Master awoke when he felt a bump; assuming it was a large wave hitting the bow, he did not consider it unusual and tried to resume sleep. The collision caused the dredger to roll over and capsize in as little as 20 seconds. Neither of the two crew members survived.

The investigation found, among other things, that the bulk carrier's OOW had reduced situational awareness due to unnecessary distractions; he had not seen the dredger until the last moment. The tablet had been almost constantly in use for over two hours, during which no interaction with navigational equipment such as target acquisition on the radar or target interrogation on the ECDIS was recorded on the Voyage Data Recorder (VDR). Additionally, the bridge equipment was not set optimally, and the alarms designed to warn of dangerous situations had been disabled, silenced or switched off. The investigation also found that, subsequent to tests after the accident, the OOW had been under the influence of alcohol at the time of the tragedy.

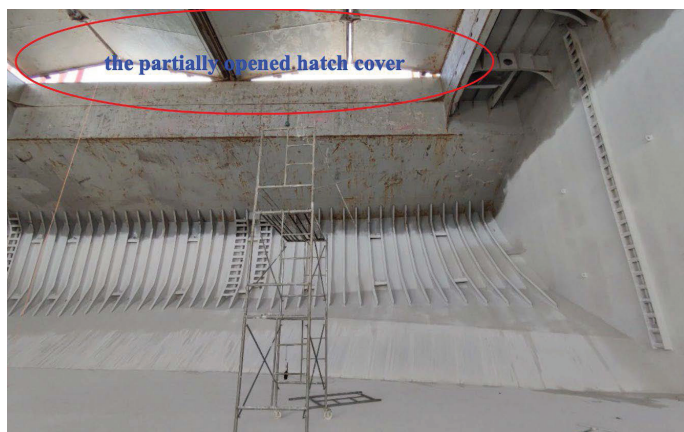
The crew members working in the cargo hold came out to the main deck and asked why the hatch cover was closed. The deck crew replied that no one was operating the hatch cover at the time; they had not closed it. The officer was then found caught between the now closed hatch cover and the coaming. A return hydraulic oil hose for the hatch cover operation had ruptured and the hydraulic oil spilled on deck. This had caused the closure of the hatch by gravity.

The investigation found, among others, that the hatch cover hydraulic lines and fittings were not incorporated into the vessel's planned maintenance system (PMS) so that the manufacturer's recommendations for use, maintenance and inspection could be correctly employed.

- The victim probably did not realise he was putting himself in a dangerous position – only the hydraulic pressure was keeping the hatch cover open. When this pressure was released due to a line failure the hatch cover quickly closed by gravity.
- Keeping hatches slightly open using only hydraulic pressure is a dangerous practice. Any deficiency in the hydraulic line can cause the hatch to quickly close without warning.
- Shipboard safety management system (SMS) procedures and the PMS should incorporate manufacturer's recommended operation, maintenance and inspection intervals.

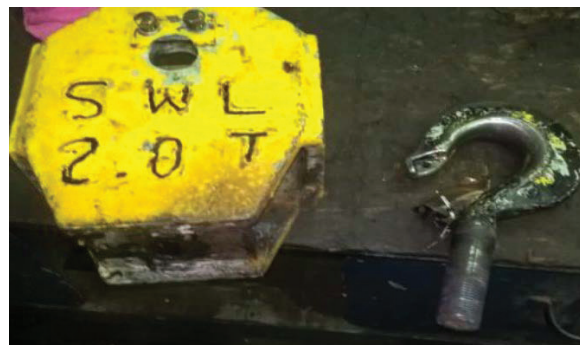
It was found that the inner mechanism of the hook was in poor condition. The thrust bearing was damaged and the threads of the hook were in poor condition.

Hook dismantled

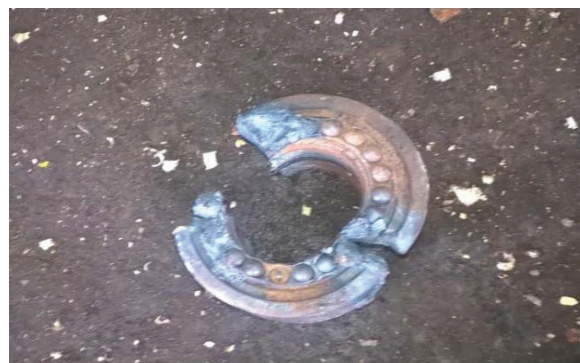
Thrust bearing found damaged
