MARS – Lessons Learned

MARS Report No 389 March 2025

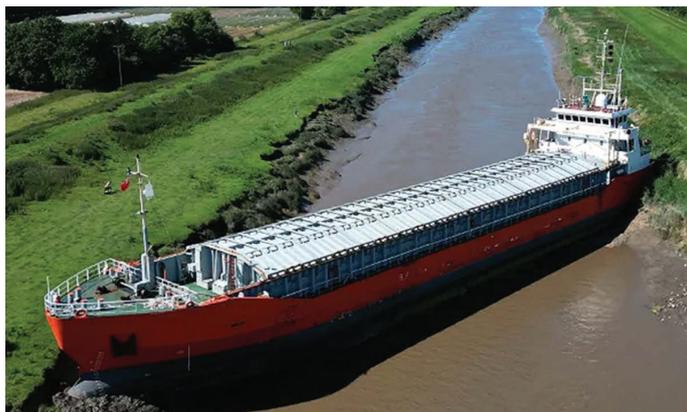
Vessel aground at low water

- The vessel had probably experienced some bank effect. The pilot's attempt to counter with strong starboard helm and a kick ahead on the main engine was, in hindsight, an over-correction.
- At the time of the over-correction, the pilot had been at the con and helm within the confines of a very restricted waterway for nearly two hours. Having to sustain such a high level of attention for such a long duration probably resulted in a lapse of concentration on the pilot's part.

- Bank effect is a pernicious but well documented hazard (see for example MARS reports 202413, 202425, 202138, 201830, 201703, 201704). While reducing speed is an excellent precautionary action to reduce bank effect, in this case the strong helm application and engine 'kick' was probably too much.
- The destination port authority has started simulator training for its pilots and has instituted a review of vessel suitability for transits to and from the port. Additionally, a risk assessment for vessel groundings was completed, including consideration of the benefits of requiring an escort tug.

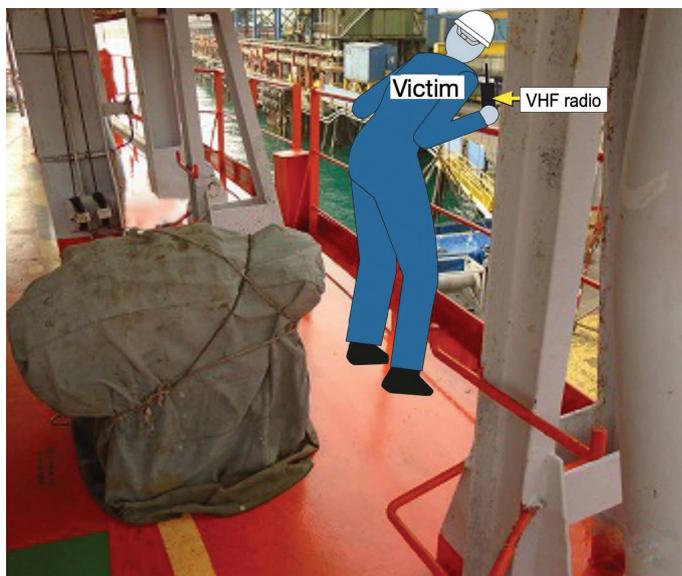
Position of victim just prior to spring line recoil

- As the vessel moved astern under its own power the aft spring line became trapped on the dock fendering.
- As the line tensioned and the vessel momentarily moved away from the jetty, the line released (like a bow string) upwards at an estimated speed of 65km/hr leaving the victim minimal opportunity to move out of its path.

- This accident is reminiscent of MARS 201870 where the victim, also at the aft mooring area, looked overboard to gain a better view and was struck by the released spring under tension.
- This accident is testament, once again, to the dangers of mooring work. Be aware of your environment and the potential hazards.
- The energy within mooring ropes can easily injure or kill. Always use extreme caution when working within the mooring area.
- If there is no clear, unimpeded path from fairlead to bollard, beware of increased tension in the line. If necessary, slacken the line until the obstruction has been cleared.

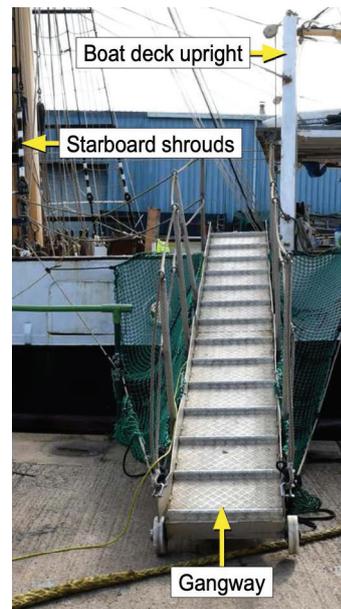
- The vessel's gangway did not provide a safe means of access to/from the vessel. Specifically, inadequate fencing and an inappropriately rigged safety net exposed all gangway users to serious hazard as they traversed the gangway.

Gangway installation with netting each side

- Safe access/egress to and from your vessel is literally where a strong safety culture starts. Make sure yours is safe.
- One for all and all for one. Look after yourself but also look out for your shipmates.
- Alcohol abuse is usually easy to spot amongst shipmates. Help them get professional help and do not indulge their impaired behaviour.

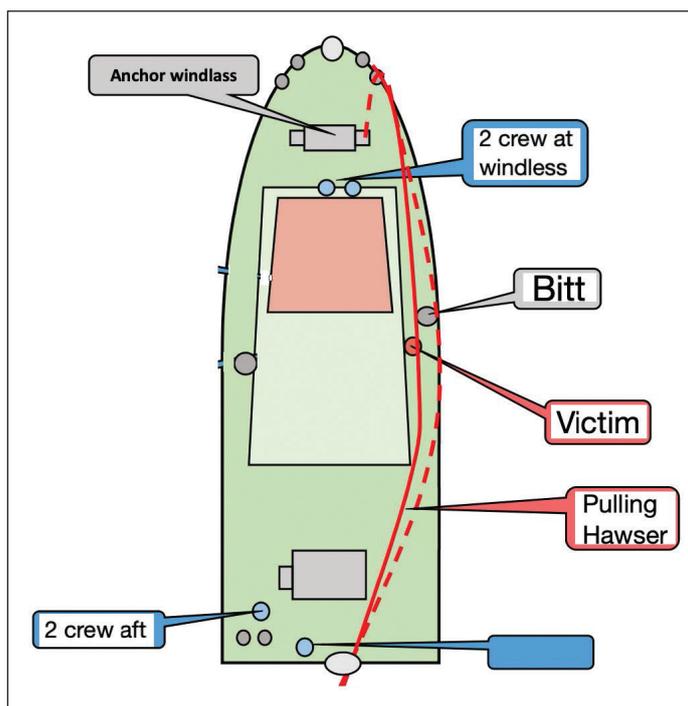
Tow line recovery arrangement and position of crew

As the tension was brought on the pulling hawser there was a loud sound and pulling was stopped at the windlass. Crew member A was found pinned against the tug's superstructure by the pulling hawser. Unknown to the other crew, who did not have a line of sight to the victim, crew member A had repositioned the pulling hawser back outboard of the bitt. When it came under tension, the pulling hawser slipped off the top of the bitt with accumulated energy and trapped crew member A against the superstructure.

- Although the accident investigation was diligent in documenting the accident facts, the analysis is a litany of 'blame the victim'. The victim certainly acted against an agreed procedure by placing the pulling hawser outboard of the bitt, but what about the lack of supervision that allowed this dangerous act?
- The agreed procedure was that no one should be located on the starboard side next to the pulling hawser – yet crew member A was there, to everyone's knowledge, until his untimely accident. Again, what of the supervision?
- Why wasn't the tug's towing winch used for this operation – a safe and straightforward method to recover the towline. The report is silent on this matter and on the dangerous improvised method used.
