MARS – Lessons Learned

MARS Report No 370 August 2023

MARS 202334

Cargo fire takes 10 days to extinguish

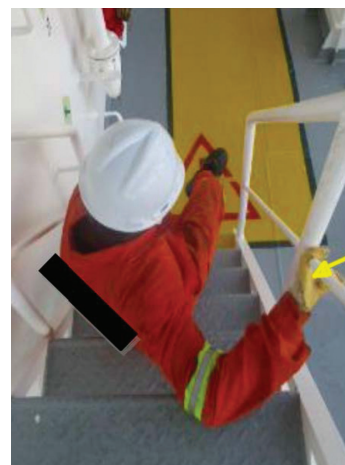
→ A vessel underway at sea was experiencing some rolling under heavy weather conditions. Crew were undertaking normal housekeeping duties. A crewmember slipped while descending a staircase and, with only his right hand lightly gripping the handrail, his efforts to stabilise his body were ineffectual. His small finger was bent back and sustained injury on the vertical post as he fell.

The company investigation found that although he had proper Personal Protective Equipment (PPE), his method of descending was suboptimal, in that, with only one hand on the right handrail, he was ignoring the good practice of having 'three points of contact' at all times. Risks were also more acute due to the rolling of the vessel.

- Everyday tasks and movements can appear less risky over time due to familiarity. Don't let your guard down!
- It is good practice to have a firm grip and use both hands on each handrail while using a staircase.
- **Editor's note** I am personally aware of another incident where an outside staircase had become more slippery over time as the anti-slip paint was gradually worn away. The gradual nature of the wearing away had led the crew to 'adapt' their behaviour and they all took great care while using the staircase – but hadn't yet thought to redo the anti-slip paint! When an outside party came to audit the vessel, she fell on that very staircase due to it being wet and slippery. Luckily, she was not badly injured.

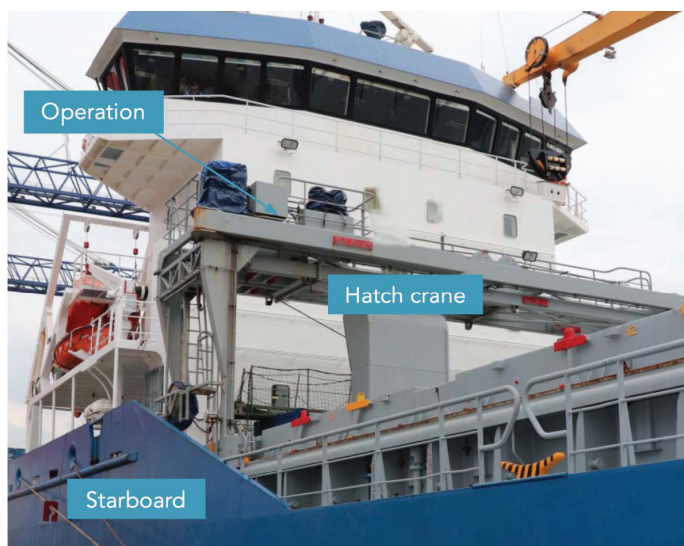
- The crane operator's field of view is severely restricted and does not allow a proper overview of both sides of the crane's track.
- The vessel layout allows persons to cross the track of the gantry crane.
- Communication with others is essential for determining if the hatch crane can be operated in a safe manner. Yet, this introduces the risk of miscommunication which was a contributing factor in at least one fatality.

Various measures have been adopted to control bad outcomes, but these appear to still have unacceptable residual risks. For example, having alarms continuously sounding while the crane is operating is well-intended – but they can become routine. Their efficacy will probably decline with time as crew become desensitised to the alarm and qualify it as 'normal'.

Emergency crane stop buttons are now a common installation. Yet analysis found that in many past occurrences the emergency stop button was not used because it was out of the victim's reach.

- Never cross the gantry crane rails while the crane is in use. If it is necessary to cross the rails, the crane should be stopped.
- Unrelated work on deck or in the holds should not be scheduled while gantry crane operations are taking place. If schedules clash, one or other of the operations should be rescheduled.

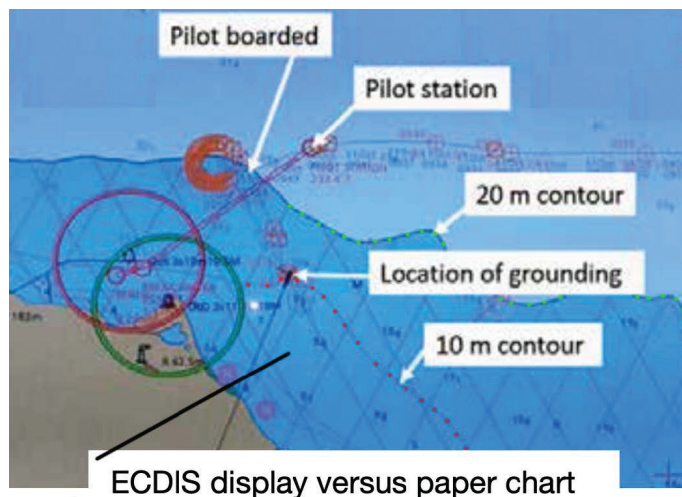
The official investigation found, among other things, that although there had been a brief exchange of basic vessel information (horsepower and stopping capability) between the Master and the pilot, there was no exchange of passage plans or discussion of the approach to the berth. The pilot did not discuss his intended circular manoeuvre to reposition the vessel for its approach to the port, and the Master did not ask about the pilot's intentions. Furthermore, the Master did not communicate with the pilot the information that he was gathering from the ECDIS and radar, including course, speed, and the rapidly approaching depth contour on which the vessel grounded. Information exchange throughout the pilotage operation was limited to the pilot's helm orders. The pilot did not request feedback from the bridge team, and none was offered.

ECDIS display versus paper chart

- Without electronic validation or input from other bridge team members, even an experienced navigator can make errors that can lead to bad outcomes if left uncorrected.
- The 'challenge' is a key principle of good BRM. When one member of the bridge team sees a developing dangerous situation, it must be communicated to the person having the con.
- In this case, the ECDIS shading was set to depict anything shallower than 20m in dark blue, to differentiate it from deeper waters, which were identified with light blue. Had waters with a depth of 10 metres and less been shaded with dark blue and marked distinctly as a no-go zone, the vessel's relatively rapid approach to the 10 metre depth contour would have been more apparent.
