MARS 202341

No inert gas means less tanker safety

MARS 202344

Collision in daylight and good visibility, take 2

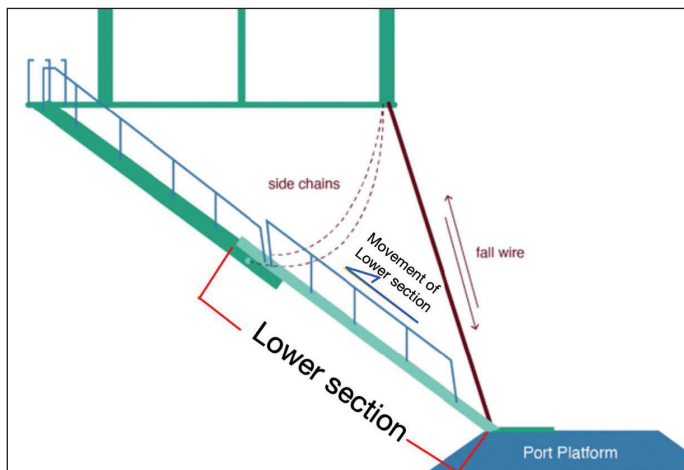
crew wedged timber between the steps to ease the weight on the victim's leg and prevent further injury.

It was decided that the safest option to free the victim's leg was to cut the step. This was accomplished, and at the same time the first responders boarded the vessel and brought the victim to hospital.

- Each close call, incident or accident is an opportunity to improve safety by analysing the events and implementing mitigating measures such as new procedures or engineering solutions. To be fully effective, the new procedures should be followed.
- Don't let your 'Can Do' attitude lead you into a dangerous position, as with the victim in this accident. Follow the established procedure.

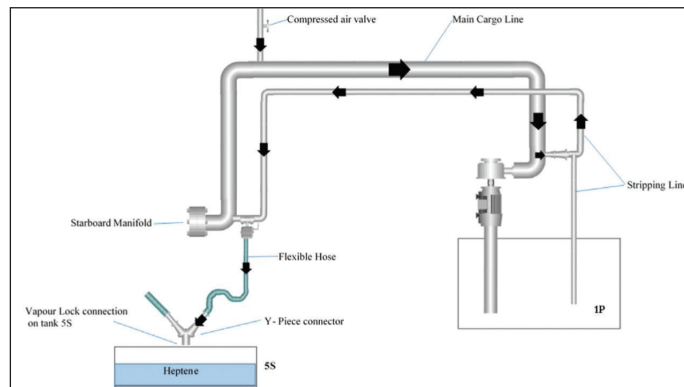
Seconds after the compressed air was blown into the discharge line, an explosion occurred. The investigation was able to discount a pressurisation event as the cause. In all likelihood, an explosive mixture ignited in tank 5S due to static electricity.

No inert gas or closed vapour return system had been used when loading this cargo. During the first outflow of cargo (safety ullage), outside air was drawn in through the pressure/vacuum valve. This allowed an explosive mixture of gas vapours and oxygen to develop in tank 5S.

The official investigation found that maximum safety assurance can only be achieved by inert loading or loading with a closed vapour return system. Ships without these systems should therefore no longer be allowed.

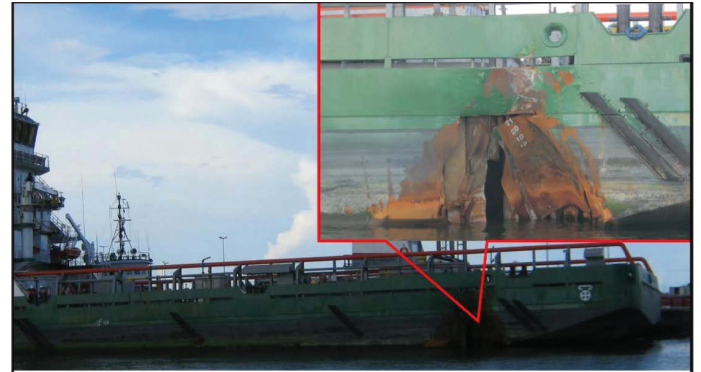
Eventually, the OOW on the OSV became aware of the risk of collision. He disengaged the autopilot, increased the throttles and turned to port to minimise the damage to the vessel as a collision was now inevitable. The bulbous bow of the bulk carrier, which was traveling at about 14 knots, struck the port side of the OSV, which was traveling at 9 knots, and breached the hull. The impact caused the OSV to heel to starboard, and water rushed over the main deck from the starboard side.

The general alarm was sounded on the OSV, and all crew were instructed to go to their muster stations. As a consequence of the collision the port side propulsion room started to flood, and the OSV began to list to port and trim by the stern. The ship's ballast pump was used to dewater the space and to get the breach to the hull out of the water as far as possible. Although the OSV lost propulsion, the electrical generators in the engine room remained operational and provided power to the ship.

OSV Damage

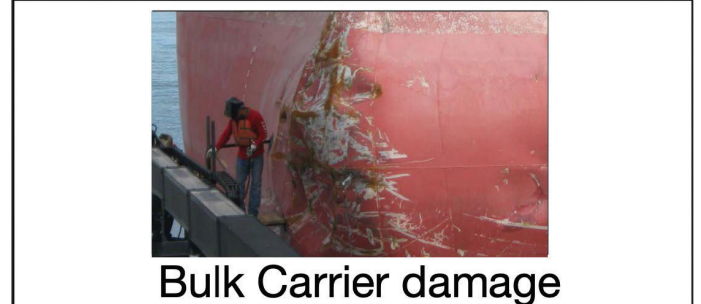
Bulk Carrier damage

The official investigation found that the probable cause of the collision between the bulk carrier and the OSV was distraction of the bulk carrier's OOW due to performing non-navigational tasks and distraction of the OOW on the OSV due to cell phone use, which kept both officers from keeping a proper lookout. Contributing to the casualty was the OOW on the OSV not following his company's watchkeeping policies, which called for two persons on the bridge at all times.
