MARS – Lessons Learned

MARS Report No 376 February 2024

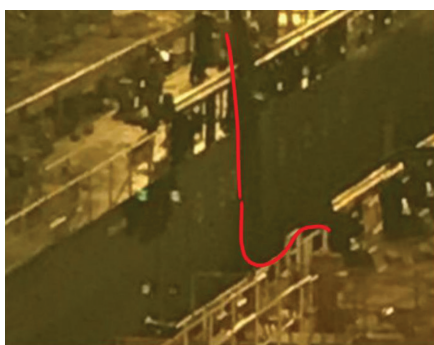
The first attempt to lift the cargo hose was unsuccessful. The hose was lifted only 10m over the upper deck, leaving another 14 metres of hose bent in a U shape between the vessels. Due to the improper lifting and U shape, the cargo line could not drain to the receiving vessel and an excessive bend developed at the hose support of the receiving vessel. This created so much pressure in the hose that the oil remaining in the hose was forced up and back out, escaping the hose at the loosely bolted flange at the supply vessel. An estimated 15L of oil was sprayed on deck, onto the fenders, and into the sea between the two vessels.

Incorrect lift causing U in hose

- STS guidance specifies blanked flanges should be securely bolted to prevent pollution.
- Introducing atmospheric air to the cargo system constitutes an explosion risk.
- A STS Joint Plan of Operations should include all operations such as cargo hose connection, draining, purging and disconnection.

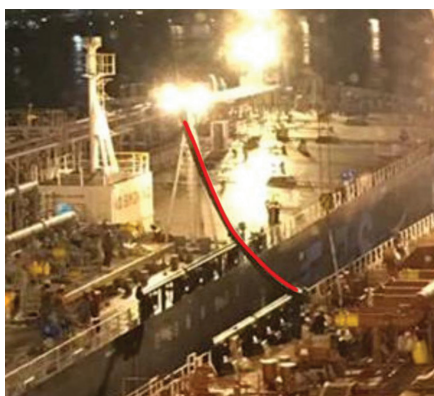
Correct lift for drainage

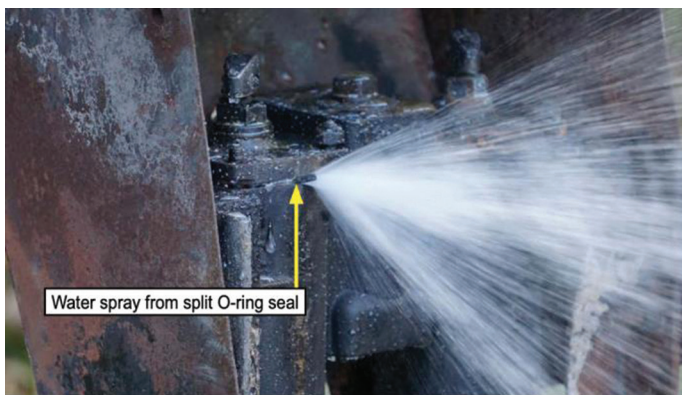
The 3rd engineer decided to clean the AE1 fuel filters as his first task. He undid the two locking screws on the splash shield and removed it from the housing to access the duplex fuel filters. As he was undoing the front right-hand nut of the filter, the fuel pressure (5.5 bar) still present in the system lifted the cover and forced the O-ring seal out of its recess, causing it to split. Marine gas oil sprayed out over a large area, covering the crewmember. The spray also reached the nearby AE2's turbocharger and exhaust pipework about 1m away. These engine parts were very hot. The fuel ignited almost immediately and thick black smoke began to emanate from the AE2 exhaust insulation.

Post-accident test using water to simulate fuel spray

- The victim's action to remove the AE1 fuel filter elements without first isolating the fuel from the filter assembly was the major contributing factor to this accident. How could this mistake have been avoided? A procedure? A checklist? Better supervision? Teamwork? Better training?
- The shore-based search and rescue team located the victim in the smoke-filled space using a thermal imaging camera. This device could be a valuable addition to shipboard emergency equipment.
- A ship fire is an imposing challenge for crew and drills that replicate the difficulties that may be faced, such as searching in near zero visibility, can pay dividends.

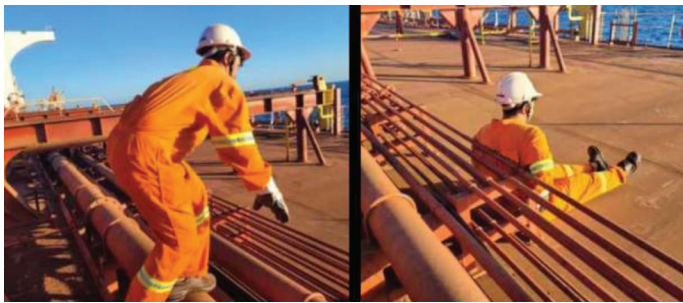
→ On a vessel at anchor, a crewmember was assigned to replace a leaking hydraulic pipe on one of the hatch covers. Once the job was completed the crewmember attempted to regain the clear deck area by walking over adjacent deck pipes that were about 50cm above deck level, rather than walking to one of the raised walkways allowing access over the pipelines at regular intervals. While walking over these raised pipes he slipped and fell, with his back striking the raised pipes. He suffered disc lesions to his lower spine.

There are raised walkways allowing access over the pipelines at regular intervals on the main deck.

- Decisions made for the sake of expediency are rarely compatible with safety.
- Ask yourself, is there a safer way? If the answer is yes, take the safer way.

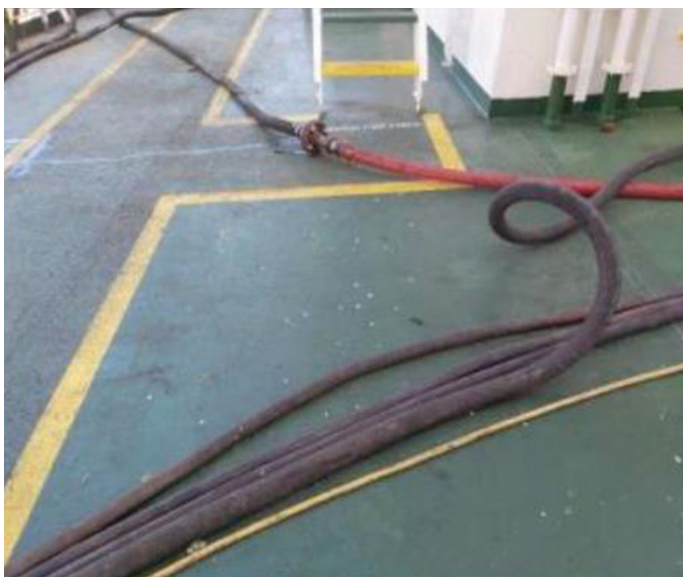
→ A ship was in dry dock and deck crewmember on the night shift was undertaking a safety round. As he reached the bottom of an exterior stairway and began walking, his foot caught a two-inch hose laid on deck. He tripped and fell, but initially thought he was uninjured. Later, his ankle became swollen and a sprained ankle was diagnosed.

- Dry dock work is notorious for snake-like arrays of hoses and other tripping hazards on deck areas. Keep walkways safe by making them as clear as possible and using high visibility cable ramps (covers) in areas where there is foot traffic over hoses.
- Keep walkways and stair landings well lit during the hours of darkness.
