# MARS – Lessons Learned

## MARS Report No 383 September 2024

### Work from height fatality

As edited from NSIA (Norway) report MARINE 2024/04

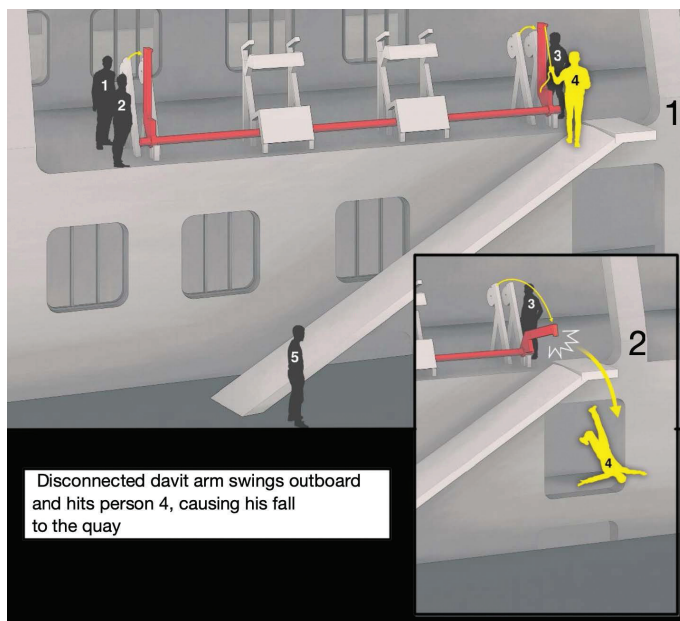
The davit was hoisted back into its cradle so that it would not obstruct access to the gangway. The davit stuck in the vertical position, and when the cable was run out further, it became slack, while the davit remained vertical. Person 4 moved from the deck onto the gangway and pulled the cable in an attempt to loosen the davit. Person 3 was told to stop the winch and put the control down. With the cable now slack, there was nothing to prevent the davit from pivoting back down to the horizontal position. As it pivoted down it struck person 4, who lost his balance and fell to the quay. First aid was administered and he was taken to a shore hospital by helicopter. He was later pronounced deceased as a result of the injuries sustained in the fall.

The investigation found, among other things, that the crew did not consider gangway rigging tasks to be 'work at height'. The crew had experience rigging the gangway from deck 1, which was lower, but not from deck 2.

The crew did not habitually wear helmets or fall protection equipment for this job when it was performed from deck 1, nor did they do so when working from on deck 2 on the day of the accident.

- A 'dynamic risk assessment' process is a technique whereby workers constantly scan the workspace for hazards and make the necessary adjustments. In this case, the method of work for gangway manipulation from deck 1 was used, although the work was being carried out on deck 2. A dynamic risk assessment process should have identified that deck 2 presented a new hazard – work from height.
- Working from height requires fall protection. Working on deck requires hard hat protection regardless of the task or location.
- As mentioned in MARS 202443, time pressures are usually self-imposed. Even if time pressures are overtly expressed, the proper mindset should be 'Safety First'.

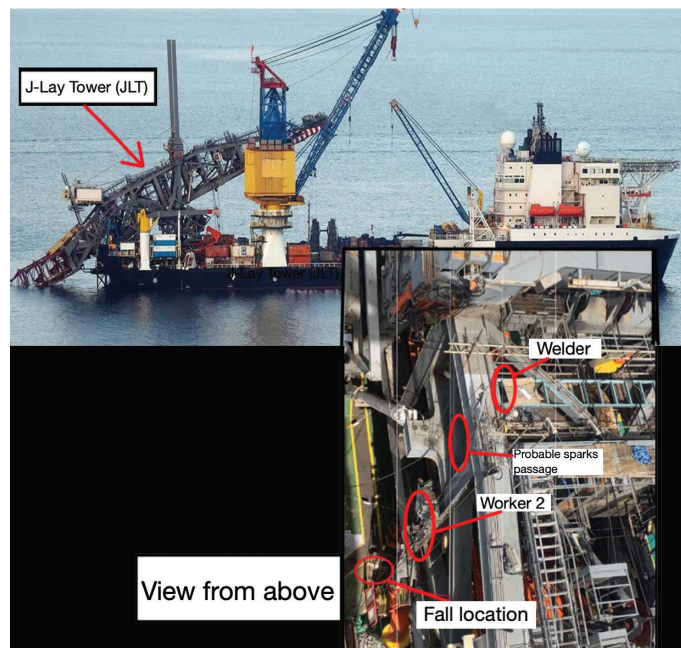
About 45 minutes after worker 2 had commenced the chipping and cleaning at height, sparks from the overhead welding operation fell into the thinner can hanging at his side. The thinner ignited. In a panic, he tried to get rid of the burning can, but it was still secured to his safety line. The can swung back on to him as a pendulum and ignited thinner splashed onto his coveralls. The fire burned the safety harness and the rope securing it, causing him to fall to the deck, where the victim continued to burn. The flames were quickly extinguished by crew and the vessel's attending doctor arrived within minutes, but after many resuscitation manoeuvres, the victim was declared deceased.

The investigation found, among other things, that the identification of simultaneous operations had not been done nor had a permit to conduct Hot Work been granted to the welding team.

- While the inadequate implementation of the vessel's Safety Management System (SMS) could be seen as the principal underlying factor of this accident, this statement is at once too general and unspecific to be of any use. Yet, if a company's SMS is followed, such accidents should never happen.
- This accident brings to light the importance of identifying simultaneous operations in a shared space on a vessel.
- A permit to conduct hot work should always be the first step in hot work tasks. The permit must not be a check box exercise but consist of an analysis of the work area and all existing conditions and hazards.

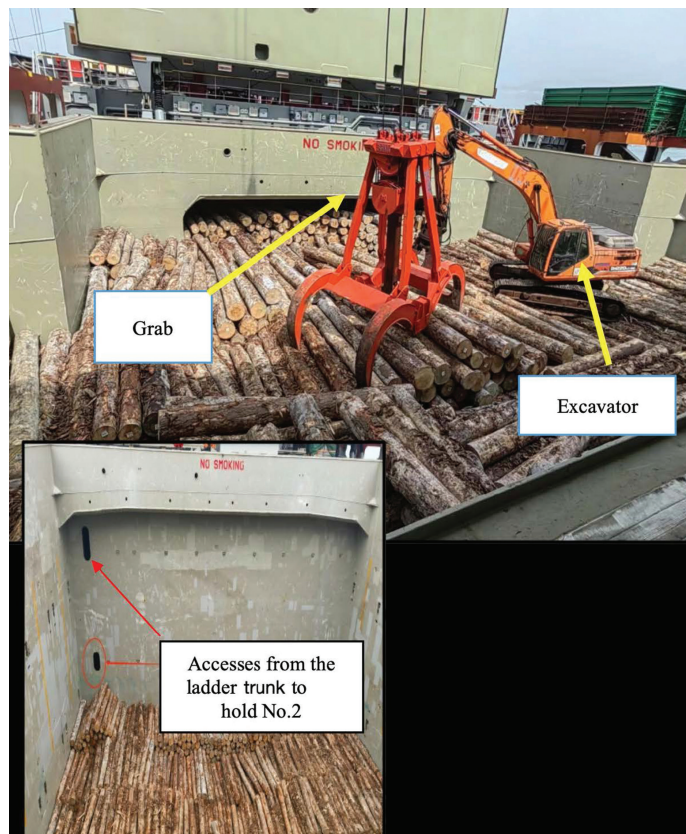
The investigation found, among other things, that the hold access trunk contained an O<sub>2</sub> concentration of only 3%, and 1.3 ppm of phosphine (a fumigation product). The level of carbon monoxide exceeded the upper range of the gas detector. The report found that if proper access controls to the entrance to the ladder trunks had been in place, the fatal accident might have been avoided.

The investigation also found that the initial actions taken by the crew in response to the emergency in the ladder trunk were not properly organised and failed to follow recommended practices. For example, the mask worn by the C/O during his solo improvised rescue attempt was only to filter toxic gases but did not provide survivable oxygen. In short, the crew were not familiar with the limitations of the mask respirator. It could be deduced that the shipboard safety training and drills for enclosed space entry and rescue were ineffective.

- Proper gas testing cannot be undertaken in six minutes using gas detectors and certainly not by using chickens.
- This accident is a prime example of a vessel's leaders bowing to the pressures of shore stevedores. A vessel's crew, by virtue of its company's SMS, are bound to ensure compliance with the enclosed space procedures on their vessel. In this case gas testing, enclosed space access, and victim rescue were all either ignored, outsourced or not properly carried out.
