MARS – Lessons Learned

MARS Report No 369 July 2023

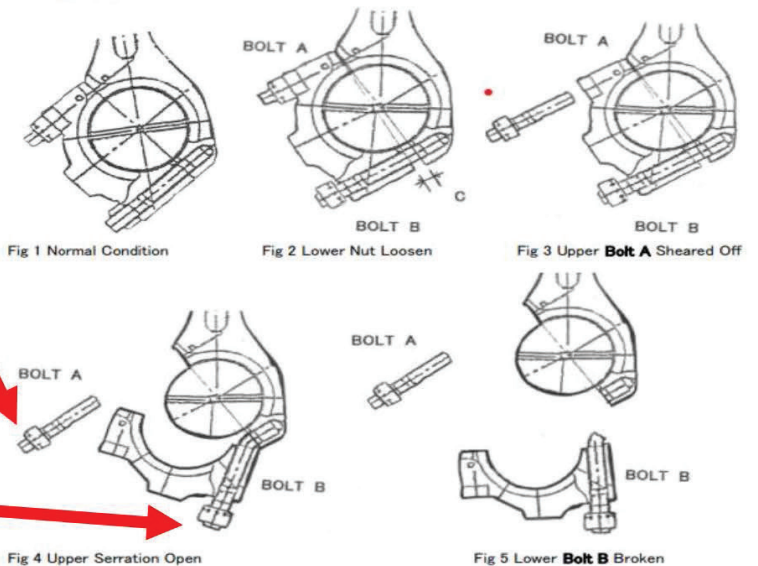
1. The con rod is tightened normally as Fig 1 and rotates 12(720min⁻¹) or 15(900 min⁻¹) times in a second.
2. In the case of the lower Bolt B is improper tightened, the Bolt B is gone to loose. The serration part B is going to open as Fig 2 with opening C.
3. The all combustion load F goes to Bolt A, the Bolt A is exceeded its strength. Then brake and shear off Bolt A in strait shape as Fig 3, the serration part A open freely as Fig 4. The tightening seats Bolt B and cap B side get the fretting and pitting marks.
4. The all combustion load F goes to Bolt B, the break and shear off Bolt B with bended shape, caused by opened serration part A hit several places, liner, cylinder block and balance weight of crankshaft as Fig 5.
