MARS – Lessons Learned

MARS Report No 368 June 2023

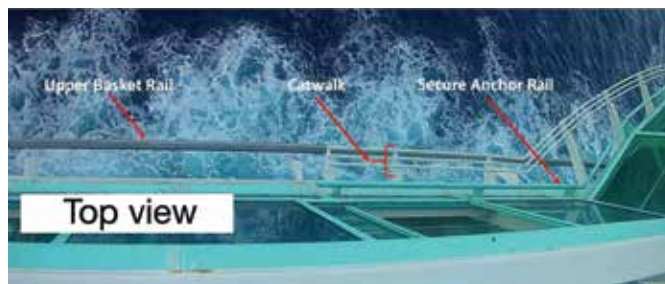
Further discrepancies included the lack of adequate external securing anchors and dedicated catwalks in the proximity of certain windows. This resulted in the deck crew having to connect to an improvised anchor point inside the frame of the window and walk on the 'upper basket rail'. This arrangement also shortened the available reach of each worker so a temporary solution using strops was necessary. The strop had to be looped inside itself to provide an anchor point, increasing the risk of confusing the secure end of the strop with the loose end.

15m section with no dedicated catwalk or secure anchor rail

- Working overboard without wearing an appropriate flotation device is extremely hazardous. Compact floatation devices that inflate upon contact with water could be more appropriate for working at height than voluminous floatation devices that restrict movement and could cause injuries when falling from tens of metres.
- Adequate resources should be made available to ensure experienced personnel oversee the maintenance procedures, ensuring all safety procedures are implemented and verified.
- When working at height, appropriately designed structures and equipment shall be in place to support and secure any individual.
